Evaluation of Residential Masonry Buildings

*Will Decker
Decker Home Services*

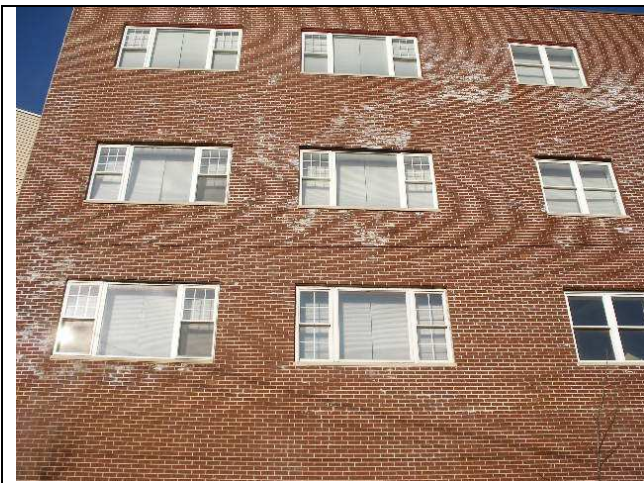
It should be noted that the last two winters (2006-2007 and 2007-2008) were relatively warm and wet, by usual Chicago area standard. Normally, Chicagoland winters (between Dec 1st and Feb 28th) average 26 F with very low relative humidity; these two winters averaged 34 F with relative humidity averaging 53. There were also many days of rain. Masonry buildings do most of their drying during the winter, when heat loss craws moisture outward and the dry air aids evaporation. Because of these two warm, wet winters, masonry buildings did not have the proper drying period. This can best be seen by the great increase of efflorescence seen after this last winter (Picture 1). Buildings constructed more recently display more pronounced efflorescence, and the pattern of the efflorescence is more distinctive (Picture 2).

Picture 1. Five year old building, Chicago

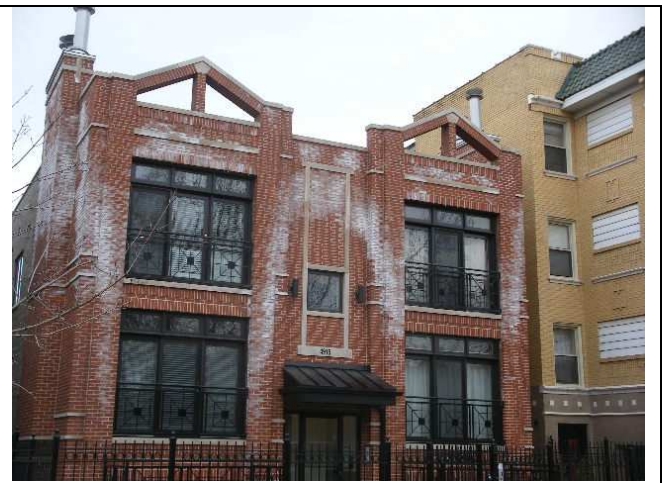
Picture 2. Two year old building, western suburbs

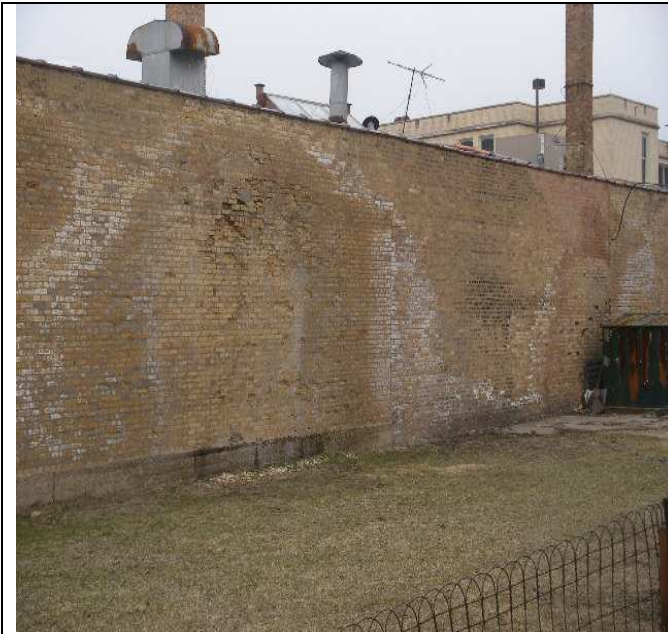
Picture 3. Older brick building, digital

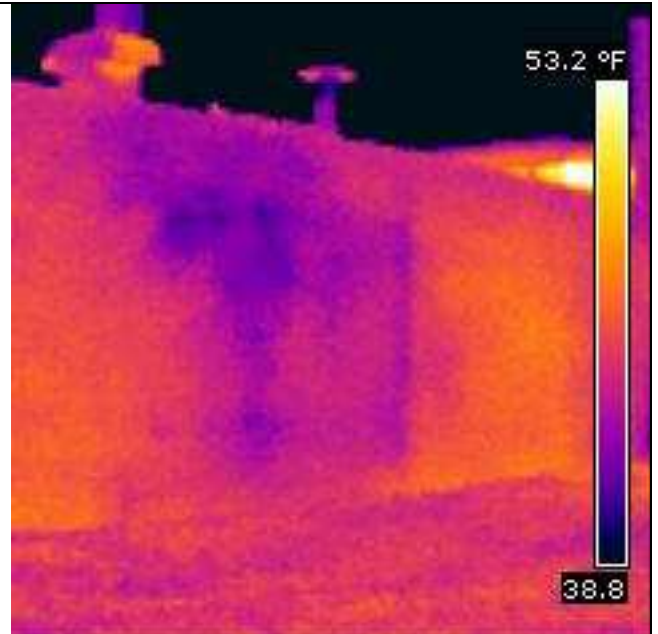
Picture 4. Older brick building, thermal

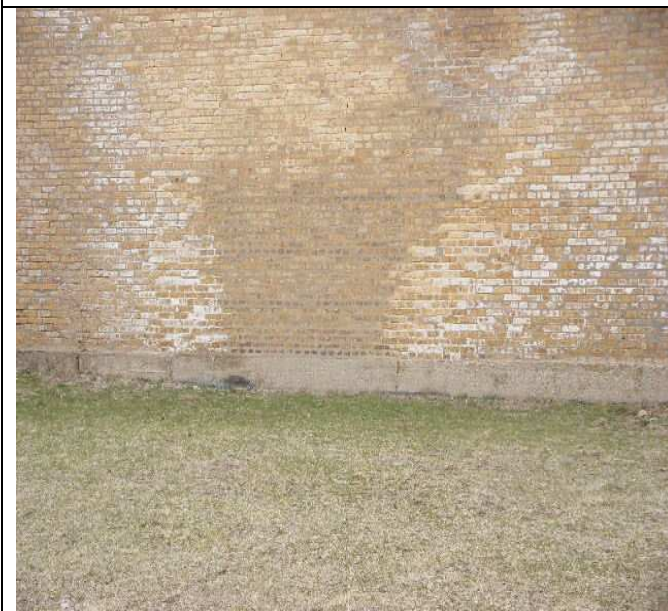
Picture 5. Wicking water efflorescence

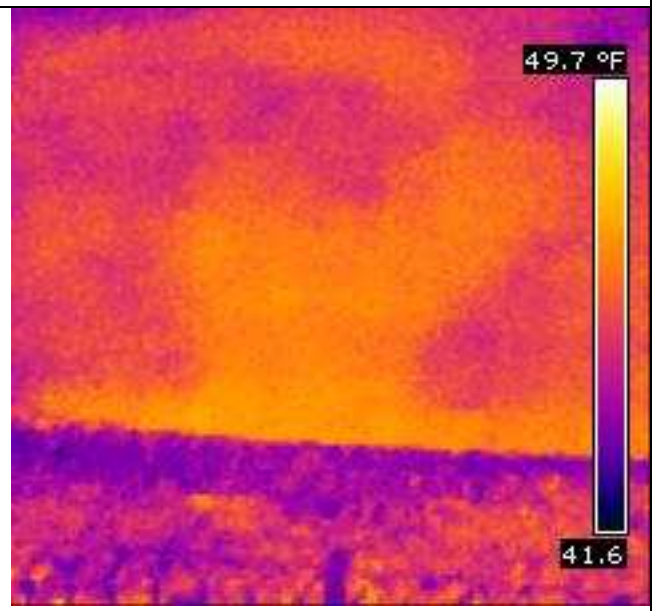
Picture 6. Wicking water, thermal

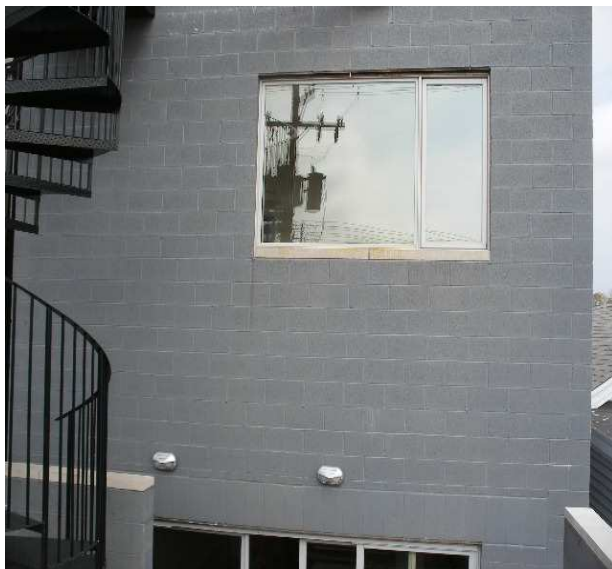
Single wythe masonry walls are not a good construction choice for the Chicago area. Because of the area’s unique micro-climate, with hot, humid summers, mild and humid spring and fall and, usually, cold and dry winters, the usual standard construction details for moisture management do not apply. With a single wythe wall masonry wall, the usual 8” CMU blocks will quickly wick moisture into the building, even with sealing of the exterior. This can best be seen in the recent building boom in our area, where new builders want to speed-up the construction time at the same time as reducing material costs. The use of standard CMU and split faced block has led to a flood of buildings reporting significant moisture intrusion. The flashing detail of single wythe walls is also not properly done. Parapet wall copings and stone window sills are readily penetrated with moisture entering the wall from above (Pictures 7, 8).

Picture 7. One year old SFH, single wythe CMU

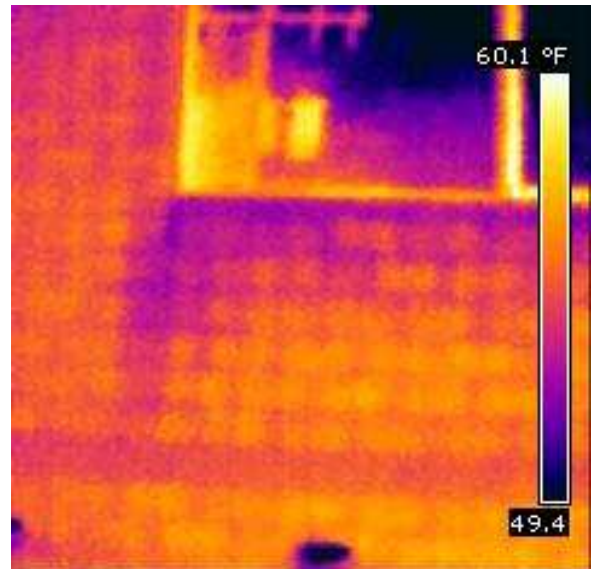
Picture 8. Water intrusion through stone sill

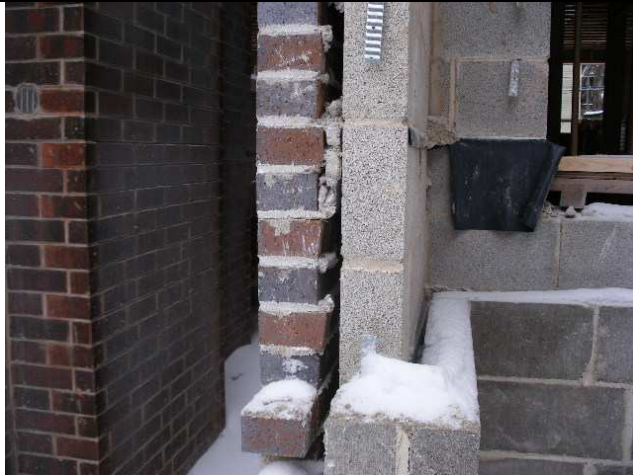
Picture 9. Mortar bridging the intra-wall gap

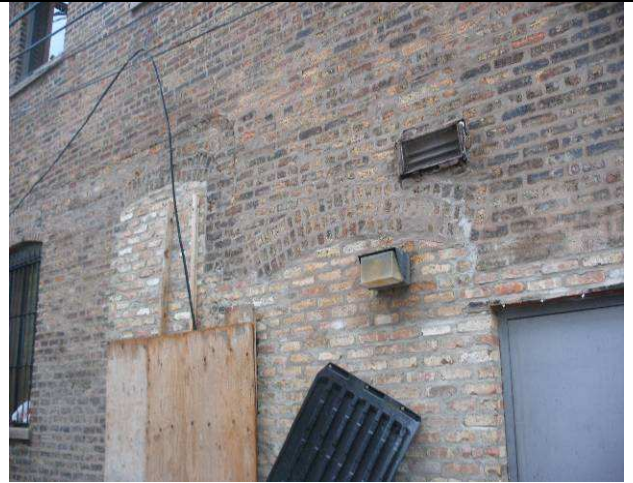
Picture 10. Window and door opening size changes

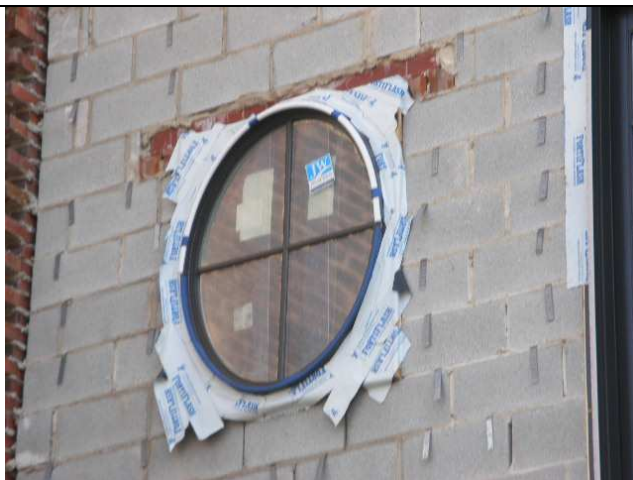
Wooden framed brick veneer walls also suffer from masonry construction problems. The usual problem is improper flashing. The building should have properly installed house wrap, properly taped, flashed or detailed around window (Picture 11, 12) and door openings. In addition to the house wrap, there should be additional flashing membrane above all windows and doors. This flashing should be installed over the lintels and be equipped with end dams. Lack of care during construction often leaves these flashings damaged (Picture 13). All too often, the masonry / lintel space, even when equipped with weep wicks, is grouted or caulked. Sealing of this masonry / lintel space does not allow for proper drainage of flashing moisture. Even if the required end dams are installed, if the lintel spaces are sealed, water will over run them and cause increased moisture to enter around window and door frames (Picture 14).

Picture 11. Improper flashing above window

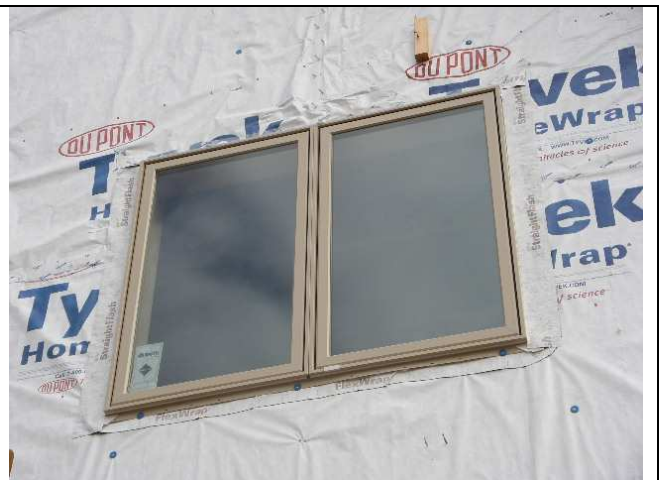
Picture 12. Proper window taping detail

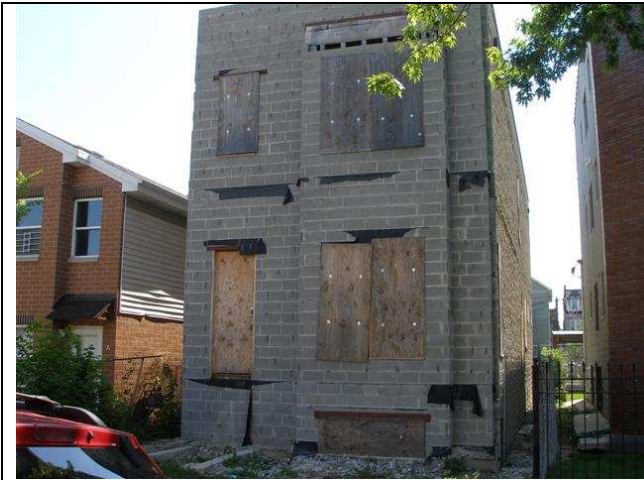
Picture 13. Deterioration of flashing

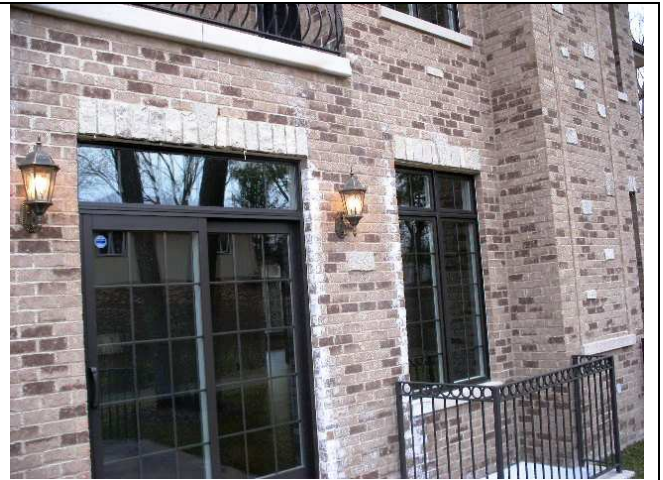
Picture 14. Water draining over end dams

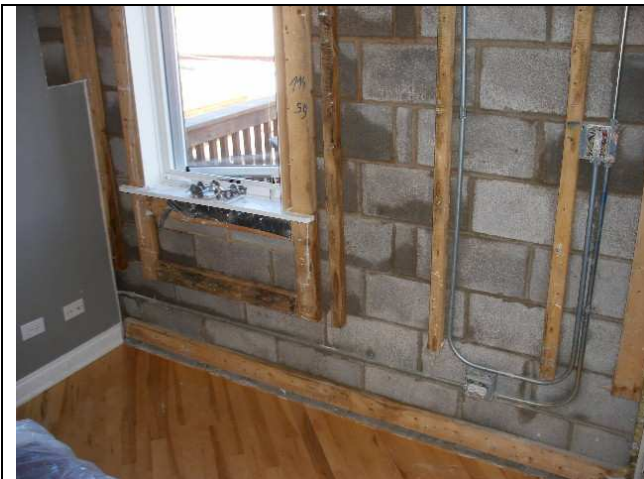
Picture 15. Water intrusion through masonry

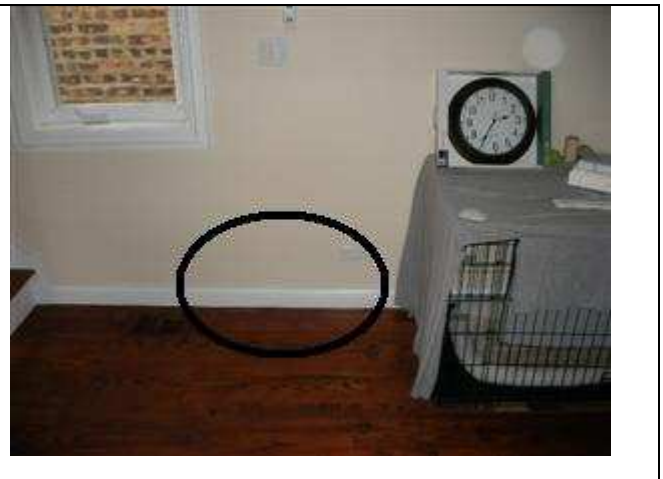
Picture 16. Exterior wall

Current construction details for masonry structure buildings in the Chicago area calls for 2" furring strips, foil backed insulation and a plastic vapor barrier before the drywall is installed. To cut costs, some Architects (and almost all builders, changing the plans) use split 2 x 4 instead of actual 2 x 2 furring strips. They insulate with un-faced fiberglass and still install the plastic behind the drywall. This leads to excessive moisture, which wicks through the masonry (Picture 115), to accumulate in the fiberglass insulation (Picture 16, 17) and, eventually, leads to mold formation (Picture 18).

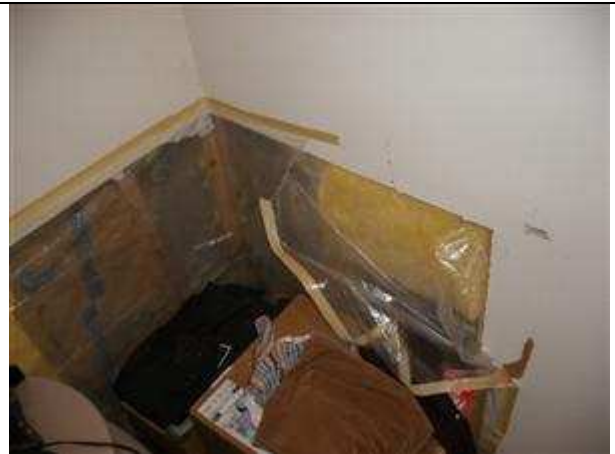
Picture 18. Moisture accumulation in wall
