Evaluation of Residential Masonry Buildings

*Will Decker
Decker Home Services*

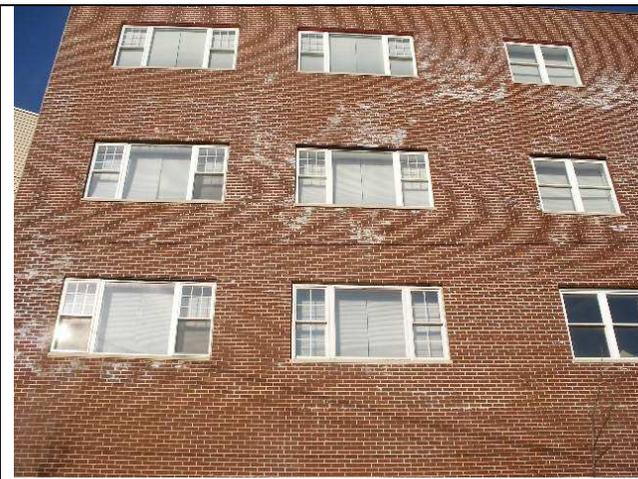
It should be noted that the last two winters (2006-2007 and 2007-2008) were relatively warm and wet, by usual Chicago area standard. Normally, Chicagoland winters (between Dec 1st and Feb 28th) average 26 F with very low relative humidity; these two winters averaged 34 F with relative humidity averaging 53. There were also many days of rain. Masonry buildings do most of their drying during the winter, when heat loss craws moisture outward and the dry air aids evaporation. Because of these two warm, wet winters, masonry buildings did not have the proper drying period. This can best be seen by the great increase of efflorescence seen after this last winter (Picture 1). Buildings constructed more recently display more pronounced efflorescence, and the pattern of the efflorescence is more distinctive (Picture 2).

Picture 1. Five year old building, Chicago

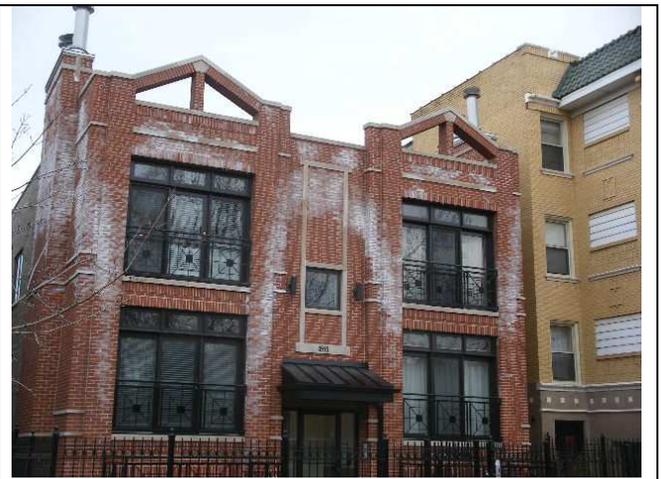
Picture 2. Two year old building, western suburbs

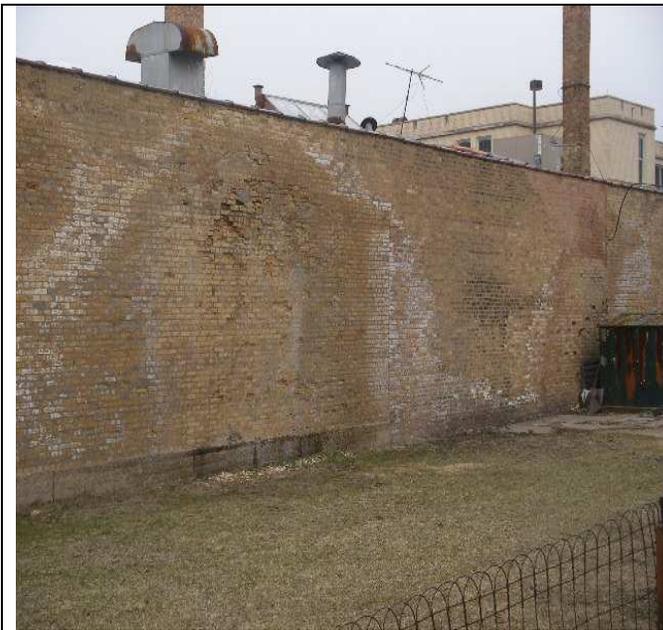
Picture 3. Older brick building, digital

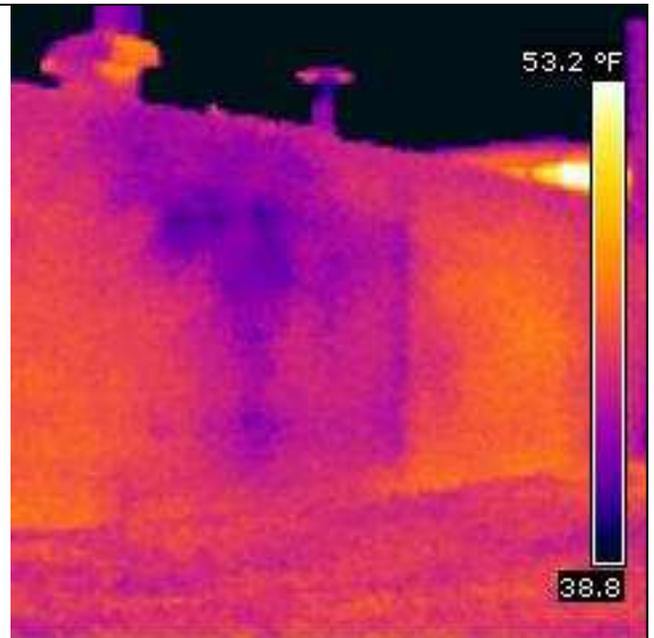
Picture 4. Older brick building, thermal

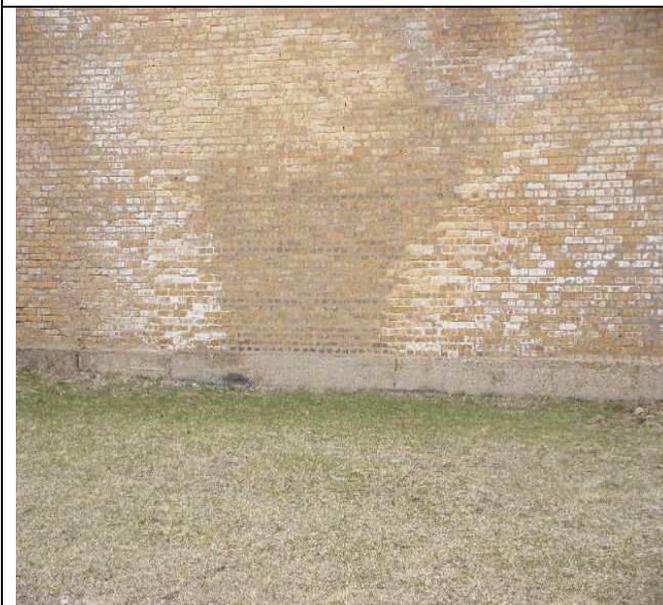
Picture 5. Wicking water efflorescence

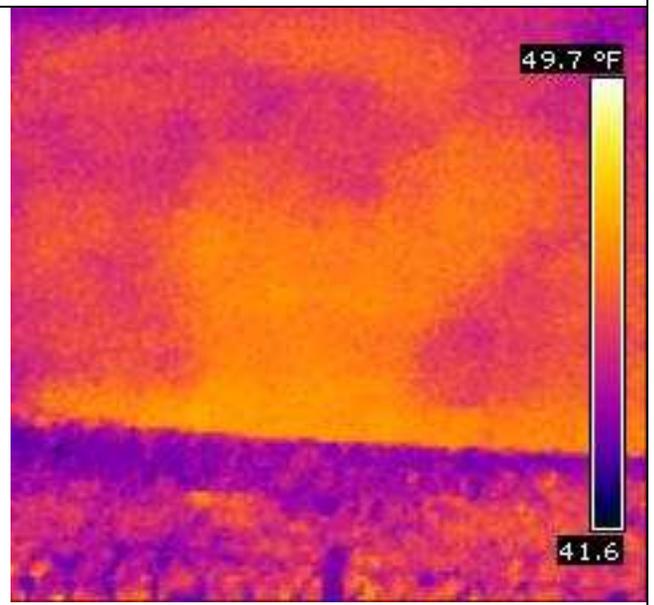
Picture 6. Wicking water, thermal

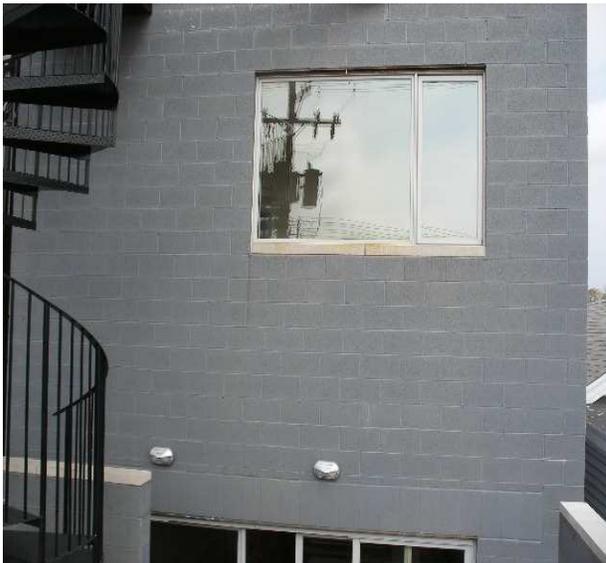
Single wythe masonry walls are not a good construction choice for the Chicago area. Because of the area’s unique micro-climate, with hot, humid summers, mild and humid spring and fall and, usually, cold and dry winters, the usual standard construction details for moisture management do not apply. With a single wythe wall masonry wall, the usual 8” CMU blocks will quickly wick moisture into the building, even with sealing of the exterior. This can best be seen in the recent building boom in our area, where new builders want to speed-up the construction time at the same time as reducing material costs. The use of standard CMU and split faced block has led to a flood of buildings reporting significant moisture intrusion. The flashing detail of single wythe walls is also not properly done. Parapet wall copings and stone window sills are readily penetrated with moisture entering the wall from above (Pictures 7, 8).

Picture 7. One year old SFH, single wythe CMU

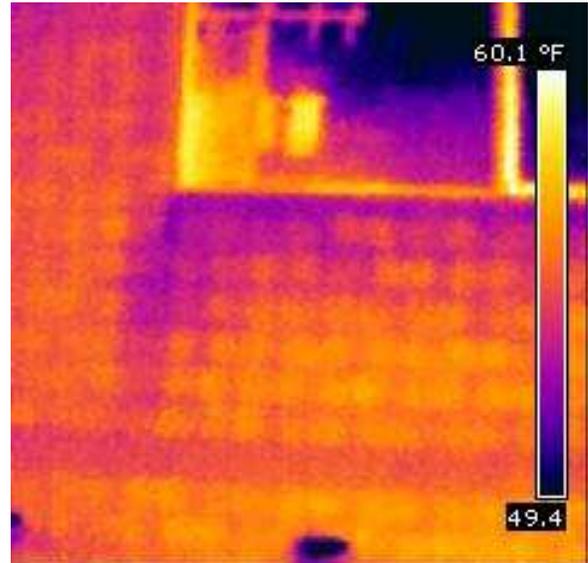
Picture 8. Water intrusion through stone sill

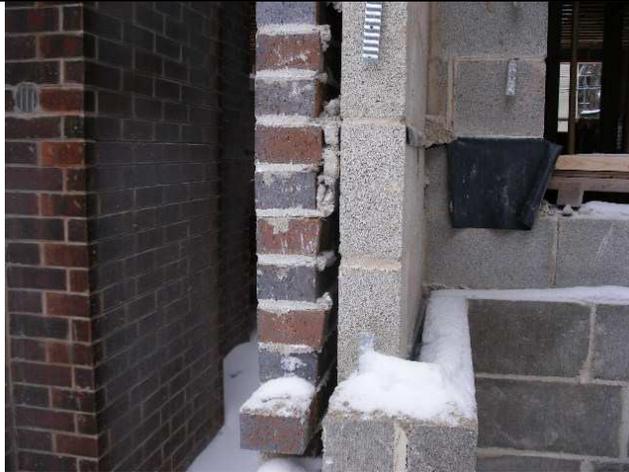
Picture 9. Mortar bridging the intra-wall gap

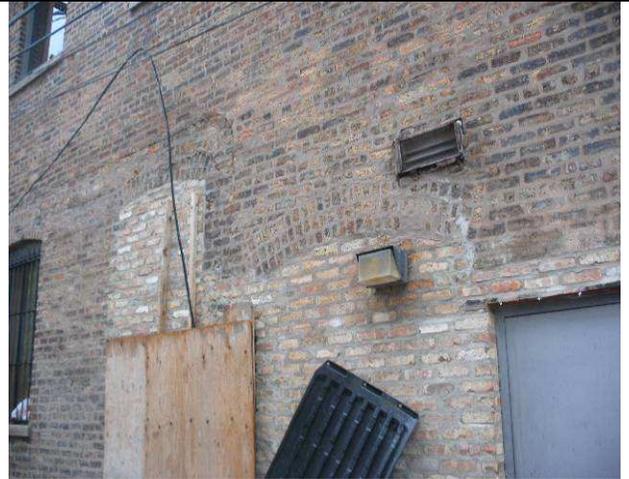
Picture 10. Window and door opening size changes

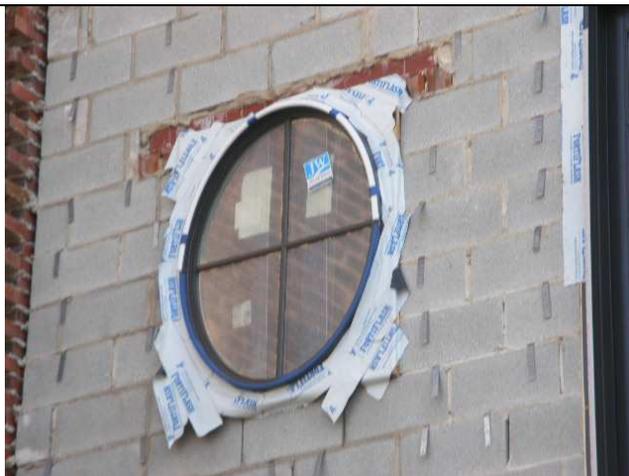
Wooden framed brick veneer walls also suffer from masonry construction problems. The usual problem is improper flashing. The building should have properly installed house wrap, properly taped, flashed or detailed around window (Picture 11, 12) and door openings. In addition to the house wrap, there should be additional flashing membrane above all windows and doors. This flashing should be installed over the lintels and be equipped with end dams. Lack of care during construction often leaves these flashings damaged (Picture 13). All too often, the masonry / lintel space, even when equipped with weep wicks, is grouted or caulked. Sealing of this masonry / lintel space does not allow for proper drainage of flashing moisture. Even if the required end dams are installed, if the lintel spaces are sealed, water will over run them and cause increased moisture to enter around window and door frames (Picture 14).

Picture 11. Improper flashing above window

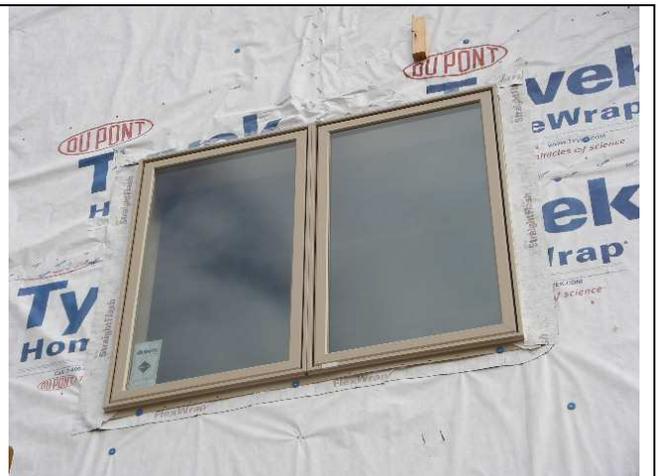
Picture 12. Proper window taping detail

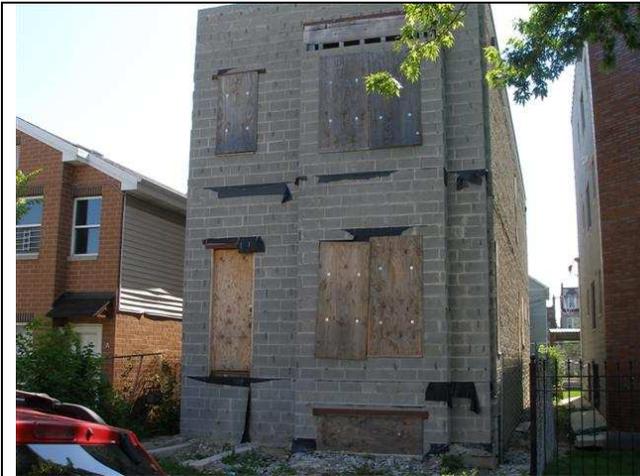
Picture 13. Deterioration of flashing

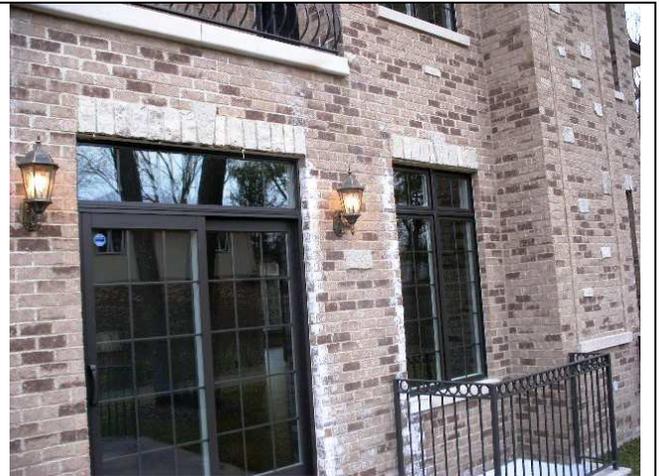
Picture 14. Water draining over end dams

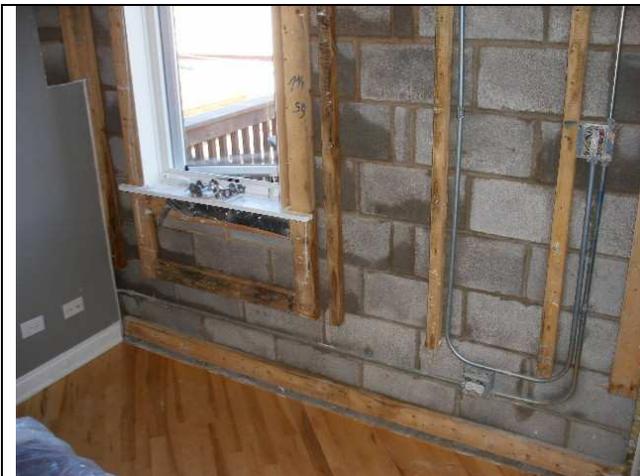
Picture 15. Water intrusion through masonry

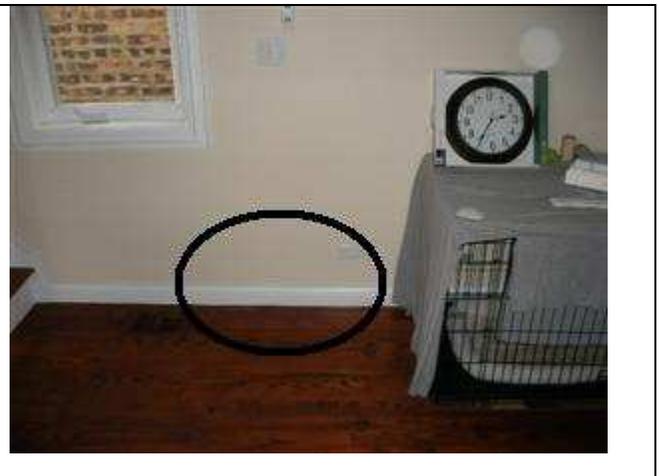
Current construction details for masonry structure buildings in the Chicago area calls for 2" furring strips, foil backed insulation and a plastic vapor barrier before the drywall is installed. To cut costs, some Architects (and almost all builders, changing the plans) use split 2 x 4 instead of actual 2 x 2 furring strips. They insulate with un-faced fiberglass and still install the plastic behind the drywall. This leads to excessive moisture, which wicks through the masonry (Picture 115), to accumulate in the fiberglass insulation (Picture 16, 17) and, eventually, leads to mold formation (Picture 18).

Picture 16. Exterior wall

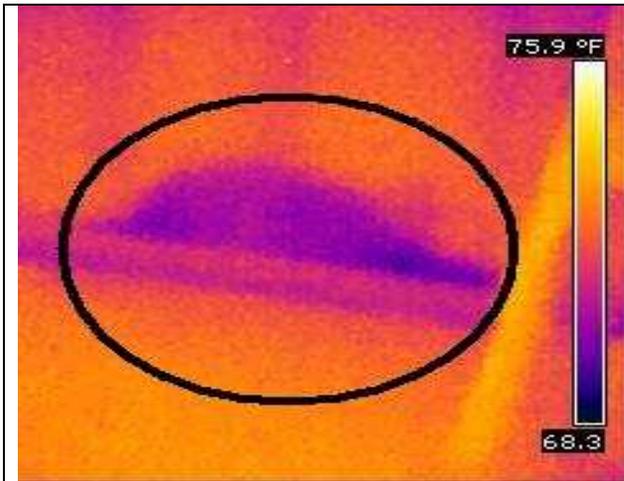
Picture 17. Exterior wall

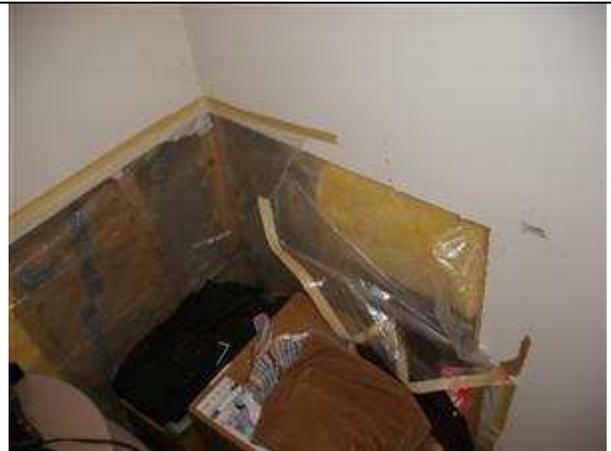
Picture 18. Moisture accumulation in wall
