**WJD Decker**  
**Home Services, LLC**

## Inspection Report

**Property Address:**  
**1234 5th St**  
**Anytown, IL**

<b>Date:</b> 6/10/2008	<b>Time:</b> 10:30 AM	<b>Report ID:</b> Sample Large
<b>Property:</b> 1234 5th St Anytown, IL	<b>Customer:</b> Joe Newhomeowner	<b>Real Estate Professional:</b>

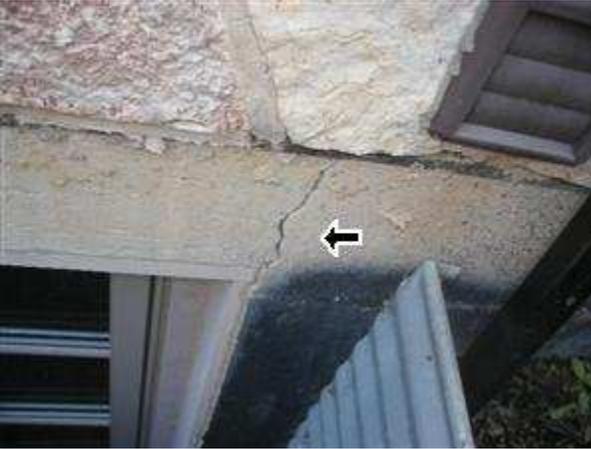
1.0 Picture 1

Foundation was poured concrete with some minor exterior signs of cracking but no efflorescence or water intrusion where observed. Interior inspection was limited because of wall finishing in basement, but there were no signs of staining in the finished portion, nor signs of water staining or intrusion in the observable portion. There were some minor settling cracks seen in the unfinished portion of the basement that was located under the garage and on the exterior radiating from the corners of the basement window frames ( Picture 1 ). These type of foundation cracks are normal and are a result of the normal settling process.

1) WL - The foundation wall exhibits some small vertical cracking. Recommend that these cracks be monitored for movement. Once movement has stopped, recommend that the cracks be sealed by urethane injection as a guard against seepage.

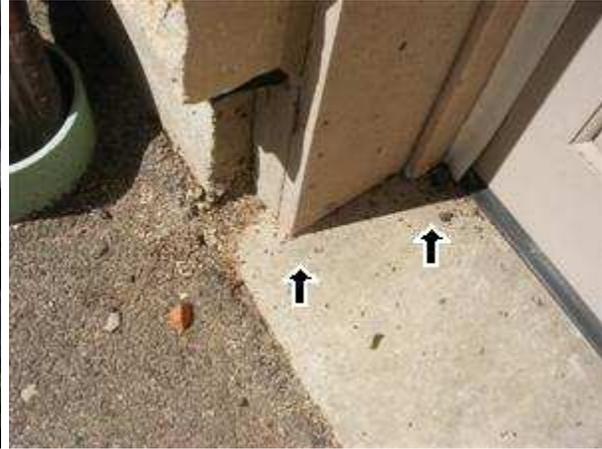
1.0 Picture 2

It should be noted that there was evidence of carpenter ant activity at the garage door lower corner areas ( Picture 2 ) and at the corresponding area in the basement under the garage ( Picture 3 ). Carpenter ants do not "eat" wood, like termites do, but merely burrow into the wood to live there. These insects can be easily dealt with by doing bi-annual perimeter spraying.

2) RR - Recommend evaluation of carpenter ants by a licensed and insured pest contractor.

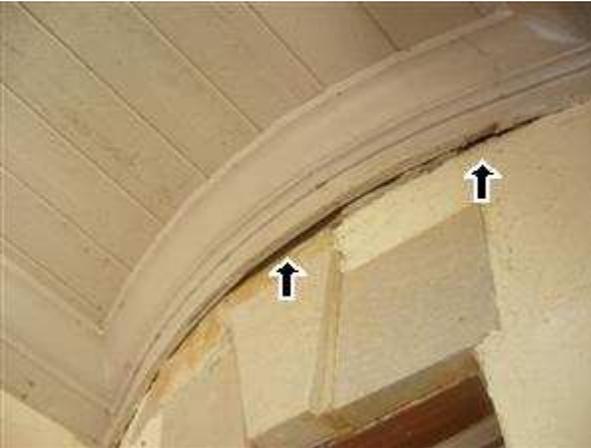
2.0 Picture 3

There was a small area, located at the front porch, where the exterior wall should be caulked to the ceiling area ( Picture 3 ).

2) RR - Recommend that the small area of wall / ceiling interface over the front porch be caulked as a guard against water and cold air intrusion.

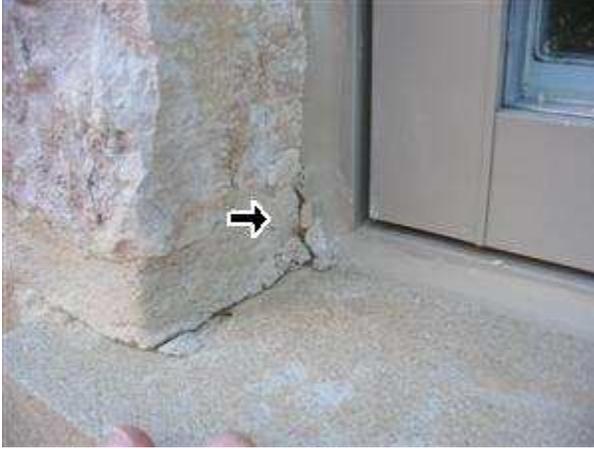
2.3 Picture 1

Exterior window frames were metal clad and displayed no signs of rust or physical damage. The condition of the wood under the cladding could not be determined. There were some small areas where the window caulking was cracked ( Picture 1 ) and should be re-caulked. The steel lintels

1) WL - Recommend that the window exteriors, where they meet the enclosure window frames, be checked semi-annually (fall and spring) for signs of cracking of the caulk and that any such cracks be properly caulked with a good quality, exterior grade, commercial elastomeric caulk.

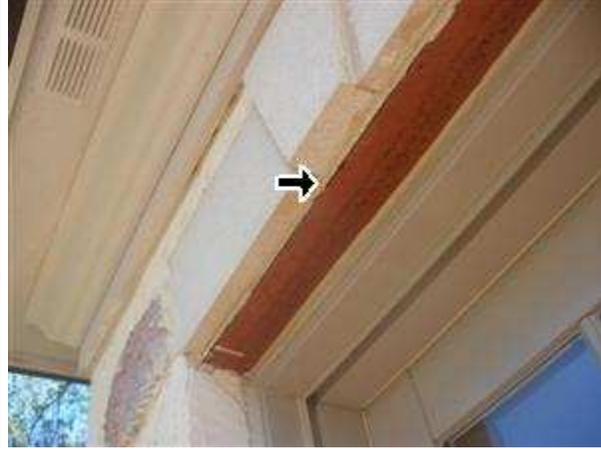
2.3 Picture 2

over the windows were not primed and painted ( Picture 2 ).

2) RR - Recommend final priming and painting of the steel window and door lintels with a good quality, exterior grade metal paint as a guard against the lintels rusting.

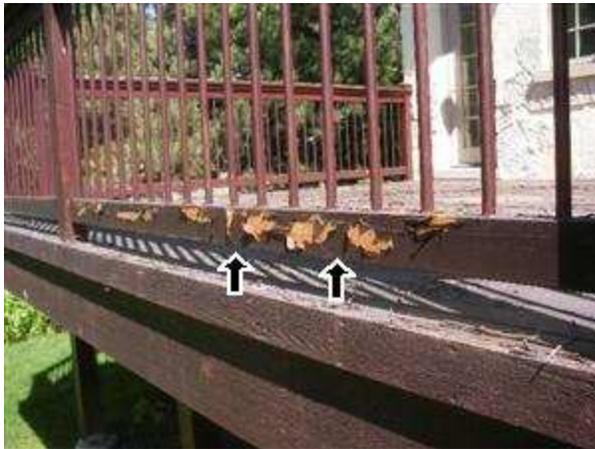
2.7 Picture 3

Both the balcony and the deck displayed signs of flaking stain ( Picture 3 ) and the deck surface stain was deteriorated ( Picture 4 ).

1) WL - Recommend that the wood of the porch be treated with a wood sealant as a guard against deterioration.

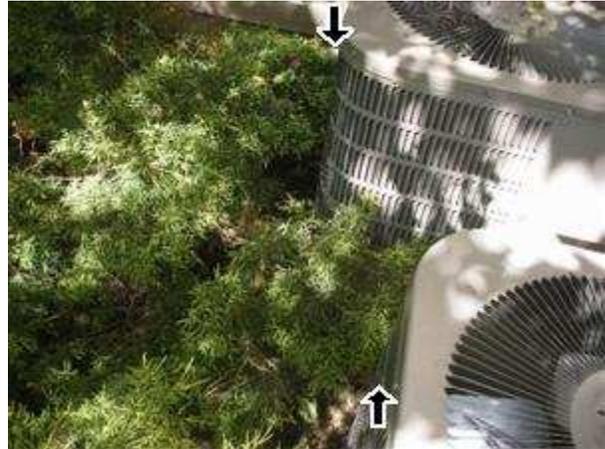
2.10 Picture 2

have its branches trimmed as a guard against damage to the stucco wall. There was also some overgrown plants that were partially blocking the proper ventilation of the A/C compressors ( Picture 2 ).

- 1) RR - Recommend that tree branches brushing the side of the house be trimmed back.
- 2) RR - Recommend that the vegetation growing around the A/C compressors be cut back.
- 3) WL - Recommend that the retaining wall on the east side of the house be monitored for signs of movement. If this wall continues to lean, recommend that it be evaluated and repaired by a licensed and insured masonry contractor.

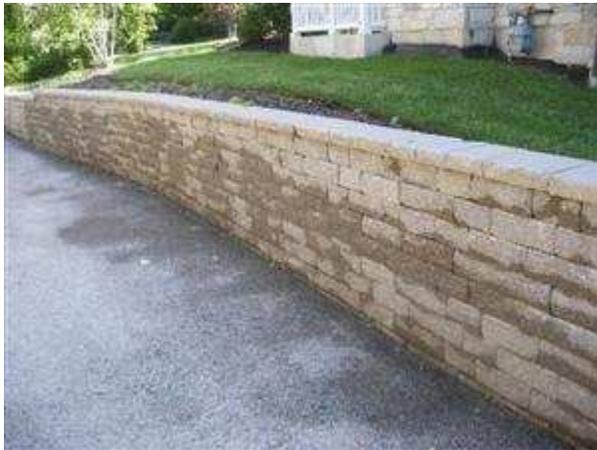
2.10 Picture 3

There is a retaining wall on the east side of the house ( Picture 3 ). It appears to be slightly leaning towards the driveway ( Picture 4 ) and it did not appear to be secured properly.

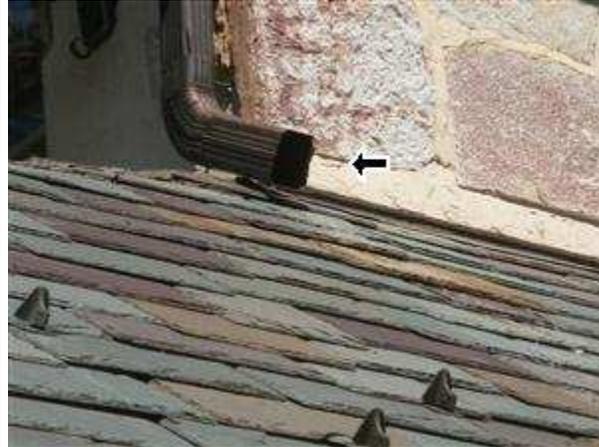
3.2 Picture 2

There are areas where the upper sections of the gutter system drain directly onto lower roof surfaces ( Picture 2 ). This will cause accelerated deterioration of the roof surface under these areas and greatly decrease the life of the roof. This condition will also violate the warranty conditions of most roofing material manufacturers.

- 1) RR - Recommend that all downspouts that drain an upper section of roof terminate either into a lower roof section gutter or to the ground, directly as a guard against excessive water buildup and accelerated roof failure. Recommend evaluation and repair by a state licensed and insured roofer.
- 2) RR - Recommend that the downspout connection to the underground drain pipes be secured with the proper adaptor as a guard against out splashing of rain water.

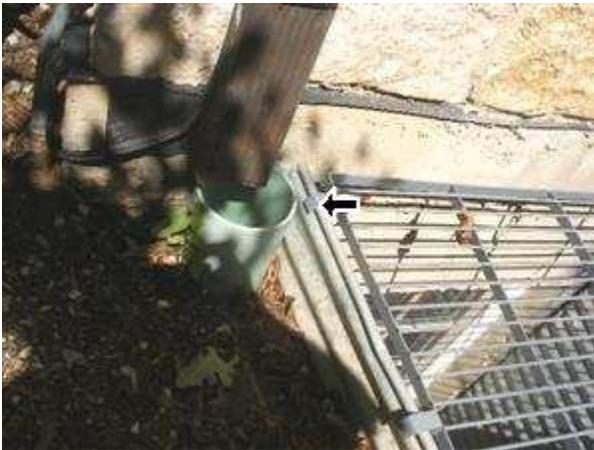
3.2 Picture 3

The downspouts were drained to underground drain piping. There were some areas where the downspouts were not properly connected to the underground drains and there was some evidence of out splashing ( Picture 3 ).

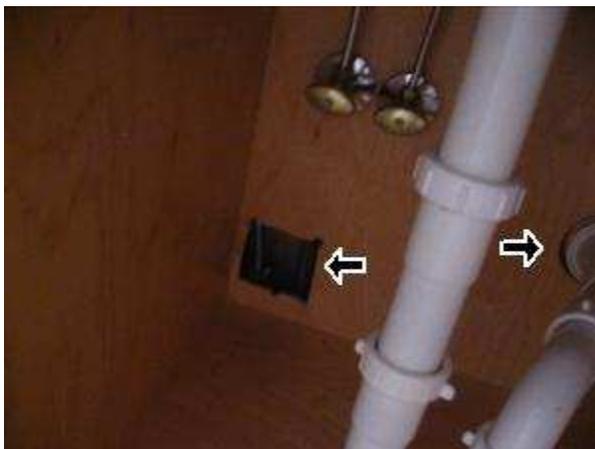
4.0 Picture 1

It should be noted that there were wall penetrations under sinks ( Picture 1 ) and basins that have not been completely sealed against pest and / or cold air infiltration. There was also an opening around the floor penetrations of the drain pipe for the master bathroom bathtub ( Picture 2 ) that should be sealed.

1) RR - Recommend that drain pipe wall penetrations under sinks and basins and the master bathroom tub be sealed with caulk or foam against cold air and pest infiltration.

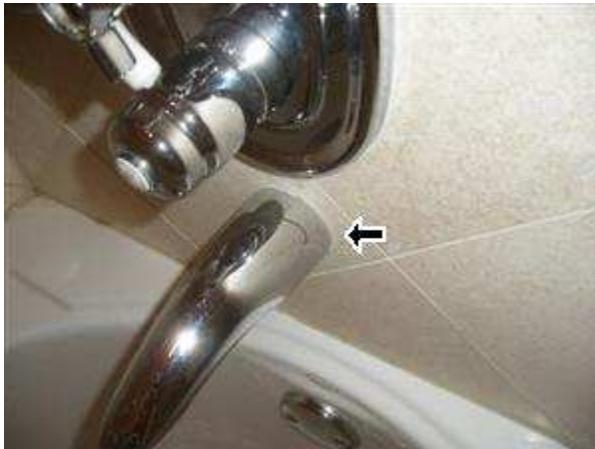
4.3 Picture 1

The bathtub spigot in the northeast bathroom ( Picture 1 ) was not properly sealed to the tile wall.

1) RR - Recommend that the bathtub spigot in the X bathroom be properly sealed to the tile wall as a guard against water intrusion into the wall.

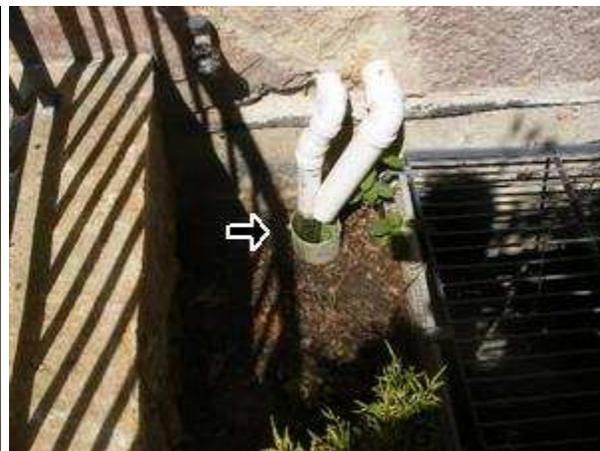
4.9 Picture 2

Where the sumps drained into underground piping (on the east side of the house, Picture 2 ) the sump pipes were oversplashing the ground pipe.

2) RR - Recommend that the sump pump pipes, where they drain into the underground piping, be equipped with an adaptor so as to avoid oversplashing.

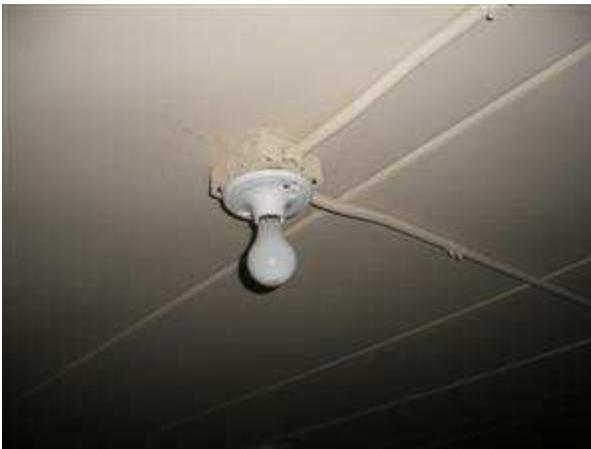
5.3 Picture 1

- Some basement and garage areas were lighted by bare bulb light fixtures ( Picture 1 ). These type of fixtures are no longer approved for use because of the possibility of the bulb breaking and / or the bulb coming in contact with flammable material and starting a fire. These fixtures should be replaced with light fixtures that protect the bulb.
- There were exterior light fixtures that were not properly sealed to the exterior wall as a guard against water infiltration into the electrical system ( Picture 2 ).

- 1) RR - Recommend that all exterior light fixtures be properly sealed to the wall to guard against water intrusion into the electrical system.
- 2) SD - Recommend that all bare bulb light fixtures be replaced with light fixtures that protect the

bulb from breakage and guard against fires. This is a safety hazard.

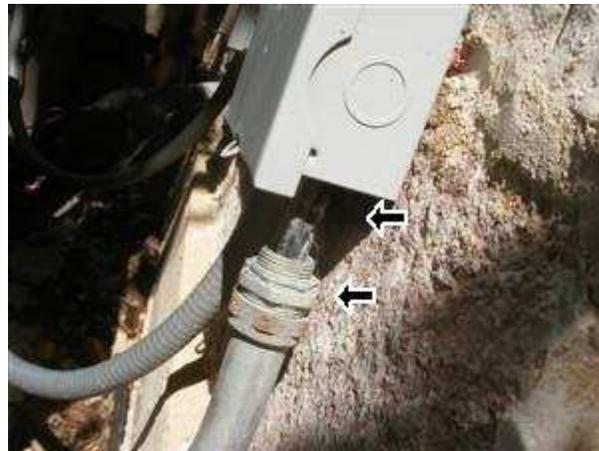
7.0 Picture 2

The power supply for one of the compressors was loose from the disconnect box ( Picture 2 ).

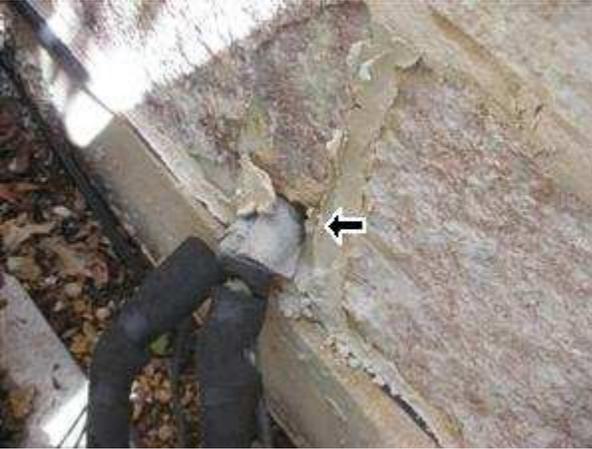
7.0 Picture 3

Where the A/C lines enter the house, the wall penetration is not properly sealed ( Picture 3 ).
