WJD Decker
Home Services, LLC

Inspection Report

**Property Address:
1121 Small Street
Smallville, IL 60000**

Date: 10/2/2008	Time: 9:30 AM	Report ID: Sample Small
Property: 1121 Small Street Smallville, IL 60000	Customer: George Small	Real Estate Professional:

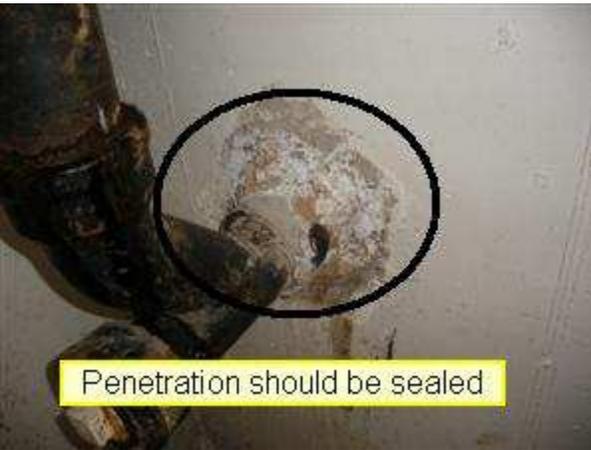
1.0 Picture 3

Foundation was poured concrete without exterior signs of cracking, efflorescence or water intrusion where observed. Interior inspection showed no signs of staining, water intrusion or efflorescence. There were a few minor cracks seen, radiating downward from the steel window pockets on the foundation wall, but these are not considered significant. There was one crack that was sealed with epoxy (Picture 1). The concrete slab displayed some minor cracking and signs of past water (efflorescence, Picture 2) but this was minor. The wall penetration for the main sewer pipe displayed some efflorescence (Picture 3) and should be sealed with epoxy.

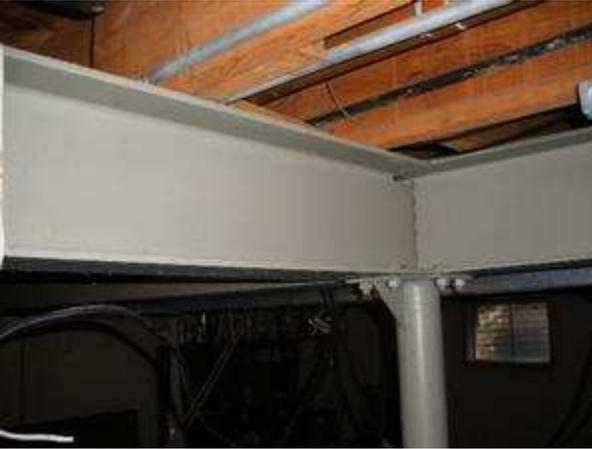
1.3 Picture 1

Structure is supported by steel girders, running east to west and a half beam (Picture 1), running north to south and supported by steel posts. The girders and posts displayed no signs of rust or displacement. The posts display no signs of rust at their bases and are not displaced.

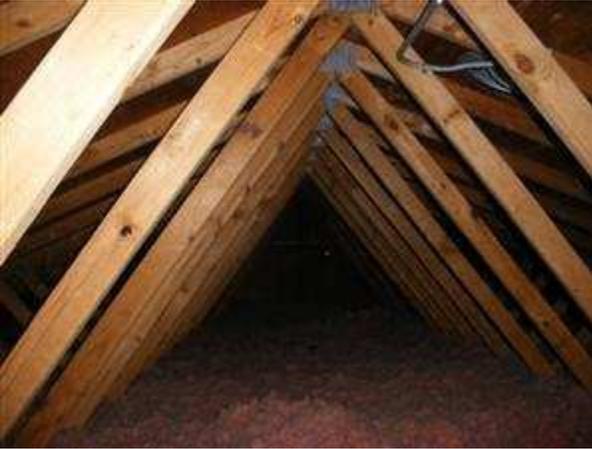
1.6 Picture 1

Attic structure was 2 x 4 wooden trusses with galvanized metal gussets in Queens truss configuration (Picture 1). The trusses were spaced approximately 24" OCD and supported exterior grade plywood roof decking. These structures displayed no signs of water staining, warp, twist or physical damage. Moisture readings were within normal limits.

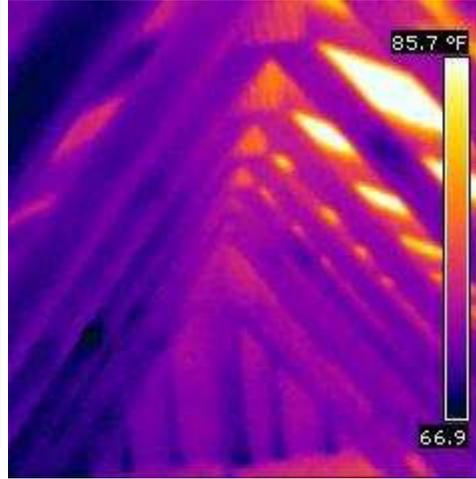
1.6 Picture 2

Thermal imaging from the attic displayed no signs of active roof leakage or excessive moisture (Picture 2).

- 1) WL - Recommend that the underside of the roof be checked every year for signs of water staining on the roof decking or rafters as an early detection method for roof leakage.

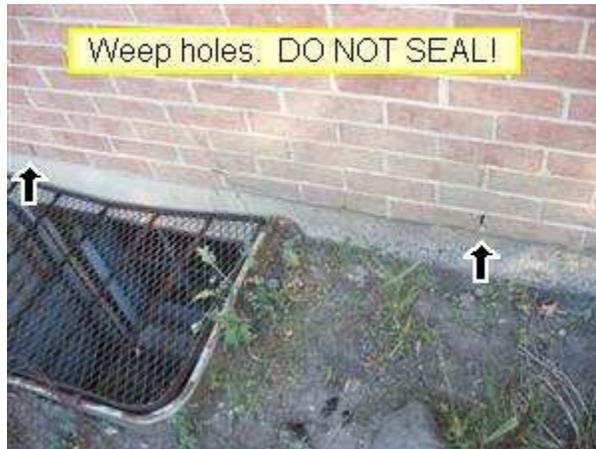
2.0 Picture 3

The exterior walls of the house were covered with vinyl siding, with the lower level covered with brick veneer with stone trim. The vinyl siding displayed no signs of physical damage and was properly secured to the house. The siding ends were properly equipped with J bar terminations. There was some small areas that displayed openings where the siding was not properly sealed (Picture 1). The brick veneer displayed some minor signs of cracking at the garage lintel (Picture 2) and was properly equipped with weep holes where it met the foundation wall (Picture 3). The limestone trim displayed no signs of cracking.

1) RR - Recommend that the minor cracks at the lintel above the garage door be sealed with mortar caulk as a guard against further deterioration.

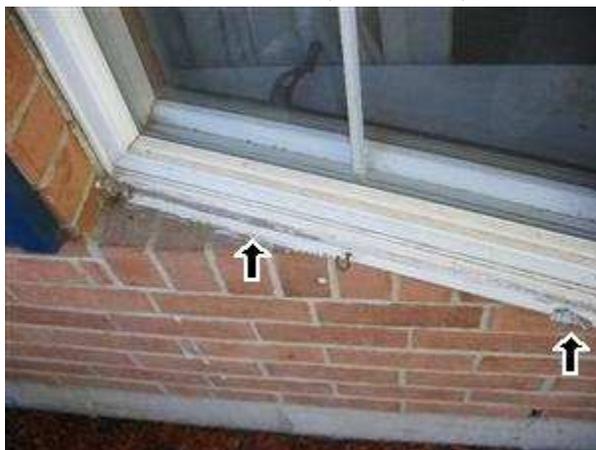
2.4 Picture 1

The exterior windows were wooden and displayed minor signs of peeling paint (Picture 1) and some caulk deterioration (Picture 2).

1) RR - Recommend that exterior window frames be scraped, primed and painted as a guard against further deterioration.

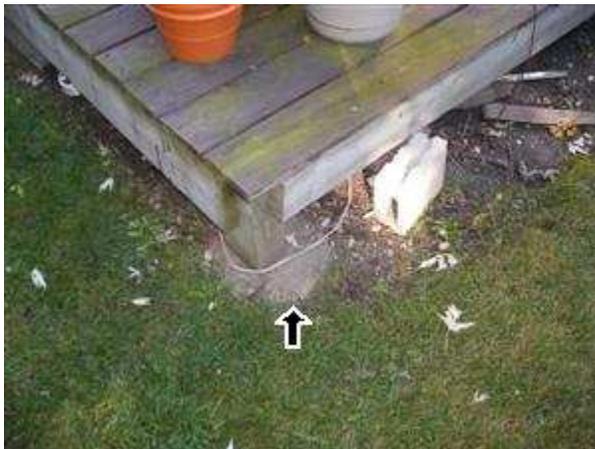
2.8 Picture 1

The rear of the house was equipped with a wooden deck which was properly footed (Picture 1) and displayed no signs of rot or unevenness. It was not equipped with railings or handrails, which are not required because the deck is not above 36". Given that there will be a small child in the house, it is recommended that railings be installed on the deck. The front porch was a concrete slab. It displayed no signs of cracking or displacement.

2) SD - Recommend that the rear deck be equipped with railings as a guard against harm to small children.

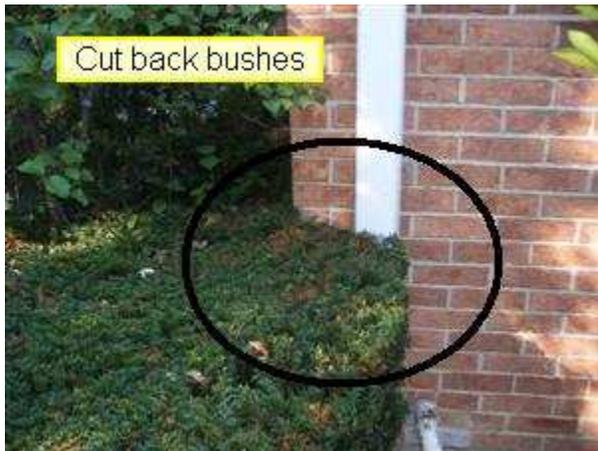
2.11 Picture 1

There was some vegetation growing against the house (Picture 1) and roof (Picture 2) that should be cut back.

2) WL - Recommend that the vegetation around the house's exterior be cut back and/or thinned out to allow for proper air flow and sunlight to properly dry the exterior of the house.

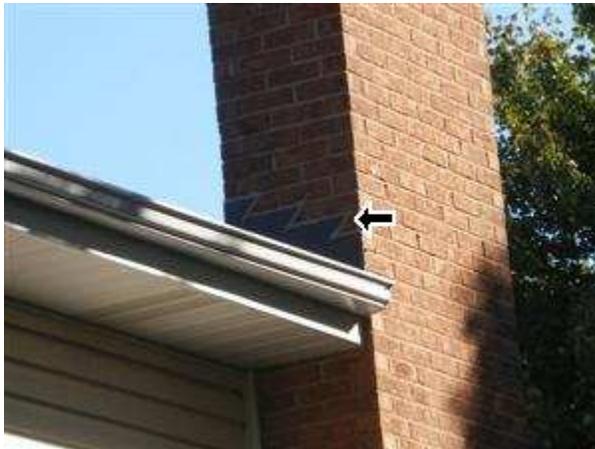
3.1 Picture 1

All roof penetrations were inspected and displayed proper flashing. The chimney was equipped with step and counter flashing (Picture 1) which was intact.

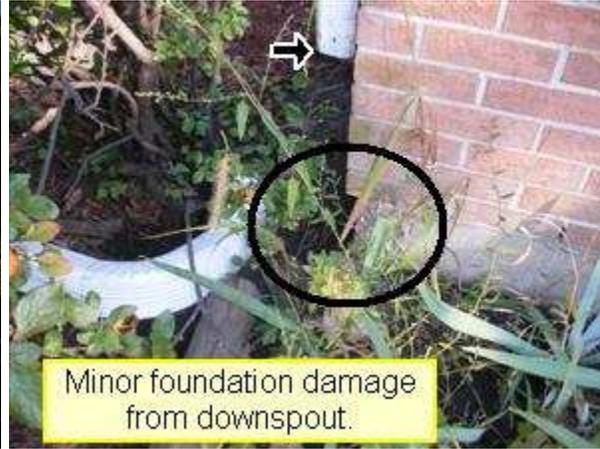
3.2 Picture 2

The downspouts displayed no signs of rust or physical damage and were properly secured to the house. There were some areas where the downspouts drained too close to the foundation of the house (Picture 2).

1) RR - Recommend that the downspouts be extended to release drainage water at least 6' away from the structure's foundation.

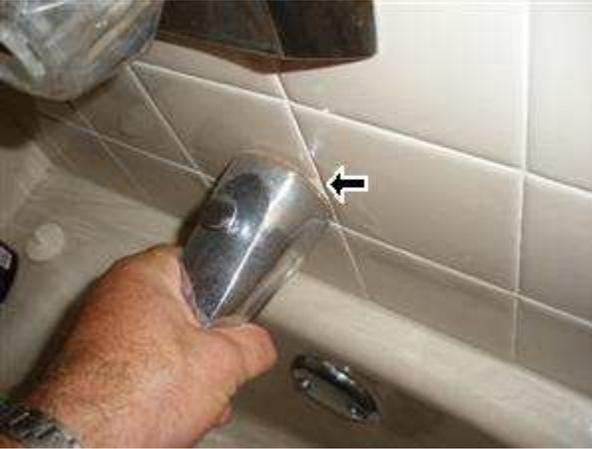
4.2 Picture 1

The bathtub spigot in the 2nd floor hallway bathroom (Picture 1) was not properly sealed to the tile wall.

- 1) WL - Recommend, as a preventative measure, that all basins, sinks and tubs be treated with a gel type drain cleaner every 2 months as a guard against drain blockage.
- 2) RR - Recommend that the bathtub spigot in the 2nd floor hallway bathroom be properly sealed to the tile wall as a guard against water intrusion into the wall.
- 3) RR - Recommend installation of an access panel to the whirlpool bathtub.

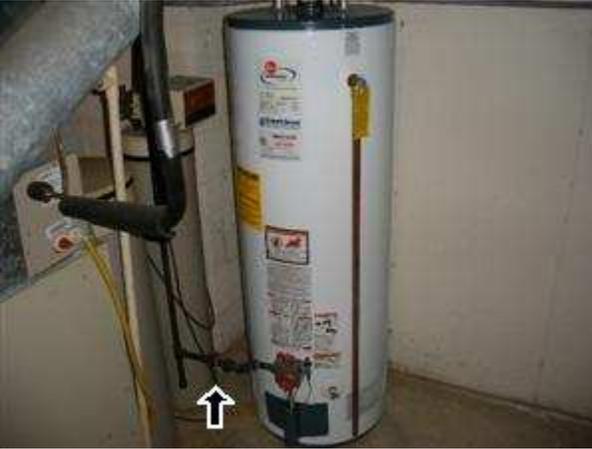
4.4 Picture 1

The water heater was properly installed with di-electric fittings. It was observed through a heating cycle and displayed the proper colored flame. The TPR valve was properly vented to an approved pipe. The water heaters vent flue was properly secured, sloped and secured to the chimney and displayed no signs of backdrafting or carbon monoxide leakage. The water heater's gas shut-off valve is indicated (Picture 1).

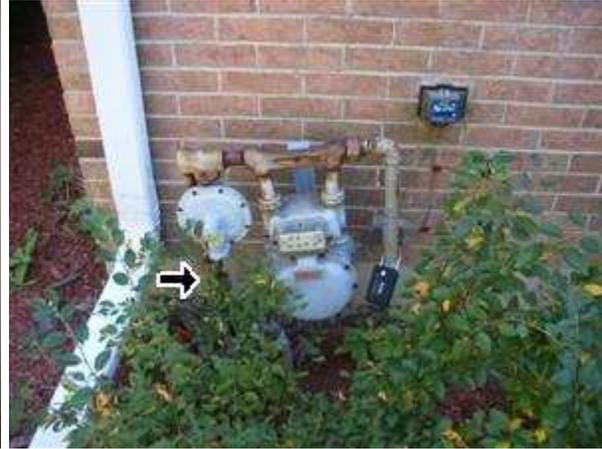
4.6 Picture 2

Main fuel (natural gas) shut-off was located on the utility meter (Picture 2).

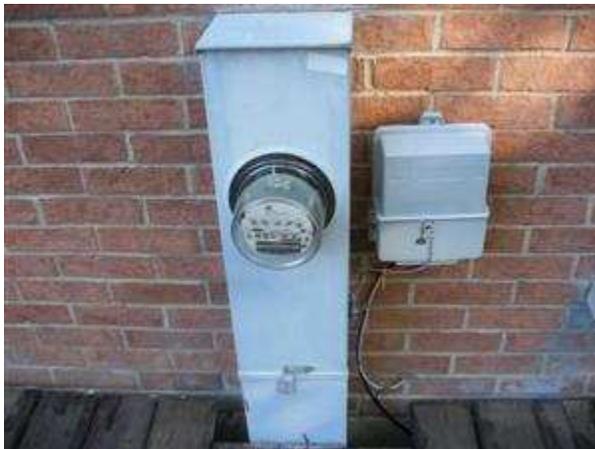
5.0 Picture 1

Electrical service is supplied by means of an underground (lateral) service drop from the utility pole to the meter box located at the rear of the house (Picture 1). The meter was rated for 200 amp service.

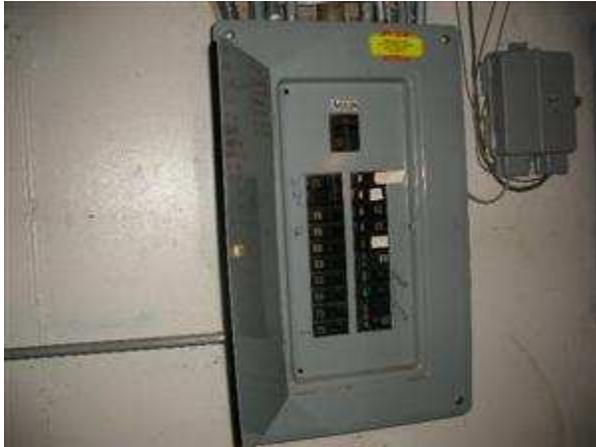
5.1 Picture 1

The service equipment panel and the main disconnect were located on the south wall of the basement (Picture 1). It was rated for 100 amps and was without signs of physical damage, rust or

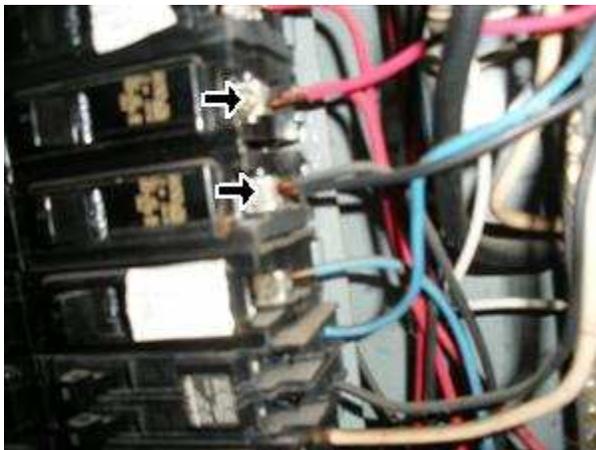
5.2 Picture 1

All overcurrent devices (circuit breakers) were of the proper type and were served by the correct gauge wire for their rated amperage. There were two double taps (Picture 1). All neutral conductors are properly seated in the neutral bus and the neutral bus is properly bonded to the panel and the ground.

1) RR - There were double tapped circuit breakers found in the electrical panel. This is when two or more branch circuit wires are attached to the same circuit breaker. Recommend this condition be evaluated and repaired by a licensed and insured electrical contractor.

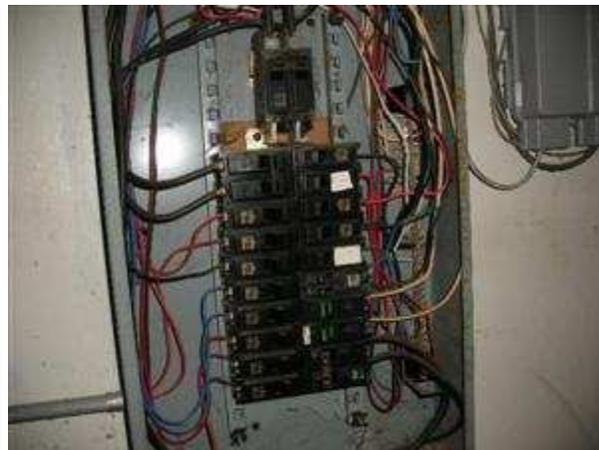
5.2 Picture 2

Wiring technique is neat and orderly (Picture 2). All raceways are properly bonded to the main service panel.

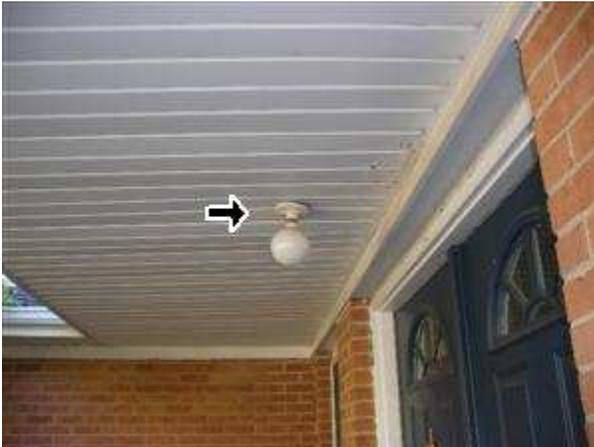
5.4 Picture 1

- Some basement and garage areas and the front porch were lighted by bare bulb light fixtures (Picture 1). These type of fixtures are no longer approved for use because of the possibility of the bulb breaking and / or the bulb coming in contact with flammable material and starting a fire. These fixtures should be replaced with light fixtures that protect the bulb.
- There were exterior light fixtures that were not properly sealed to the exterior wall as a guard against water infiltration into the electrical system (Picture 2).

1) SD - Recommend that all bare bulb light fixtures be replaced with light fixtures that protect the bulb from breakage and guard against fires. This is a safety hazard.2) RR - Recommend that all exterior light fixtures be properly sealed to the wall to guard against water intrusion into the electrical system.

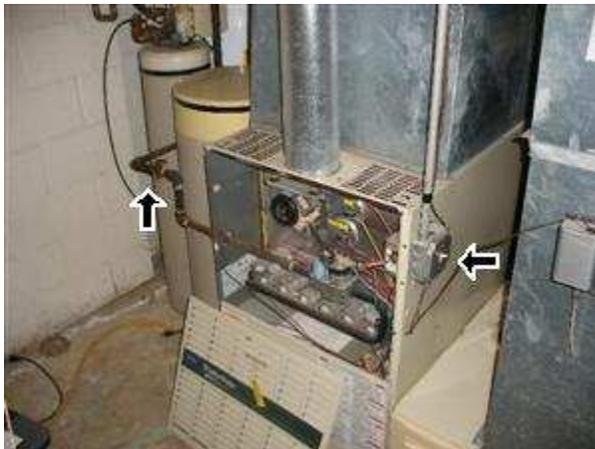
6.0 Picture 1

The subject property was heated by a Carrier category 1 mid-efficiency furnace manufactured in 1996 and located in the basement (Picture 1, gas and electrical shut-off indicated). The furnace's serial number was checked against Consumer Products Safety Commission and the manufacturer's web site for defect or recall notices and none were found.

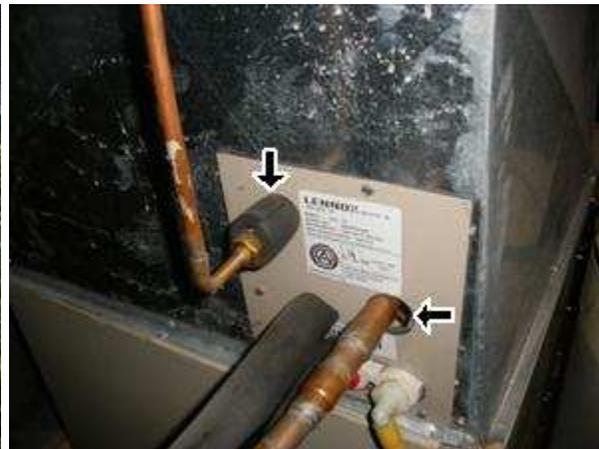
7.0 Picture 2

The lines to the plenum coil were not properly sealed to the plenum above the furnace (Picture 2). When operated, the A/C system displayed signs of refrigerant loss.

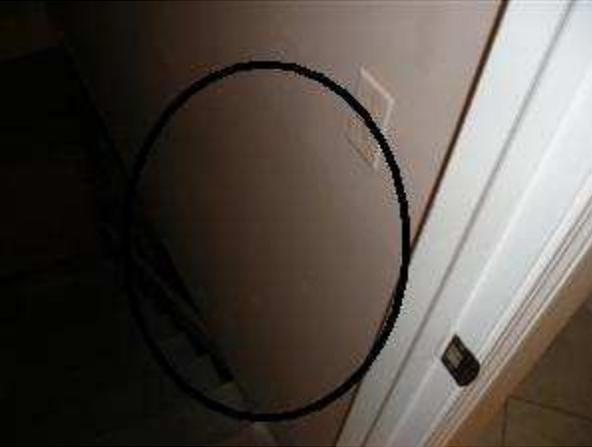
8.5 Picture 1

Upper level and basement stairs were even, tight and secure. The stairway to the basement was not properly equipped with handrails (Picture 1).

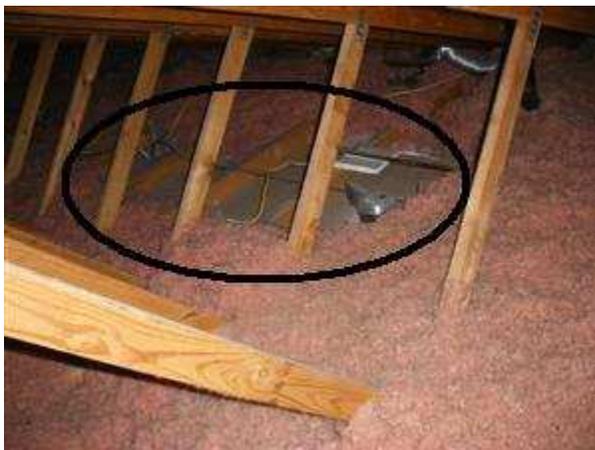
9.0 Picture 1

There were areas where the existing insullation was removed (Picture 1) and should be replaced.

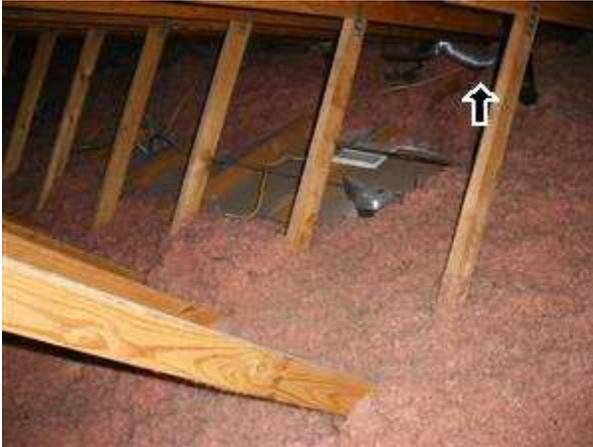
9.2 Picture 1

Bathroom were equipped with ceiling exhaust fans which was not properly vented to the exterior (Picture 1).

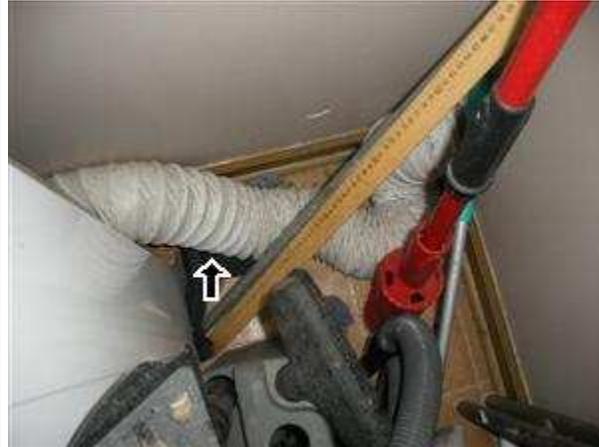
9.2 Picture 2

It should be noted that the clothes dryer vent (Picture 2) was vented by means of a vinyl vent hose. There have been many reports of fires caused by the use of vinyl vent hoses due to their flammable characteristics.

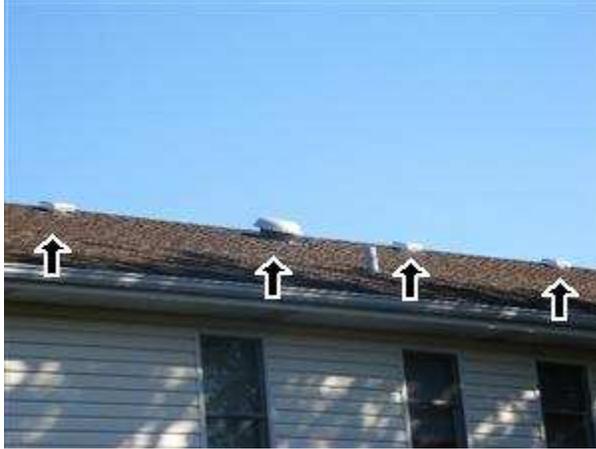
9.4 Picture 1

The attic is ventilated by a combination of soffit vents and roof vents with a power vent fan (Picture 1). The recommended baffles were not all in place (Picture 2) over the soffit vents to guard against insulation blocking the vents. There was also a power vent fan, which did not operate.

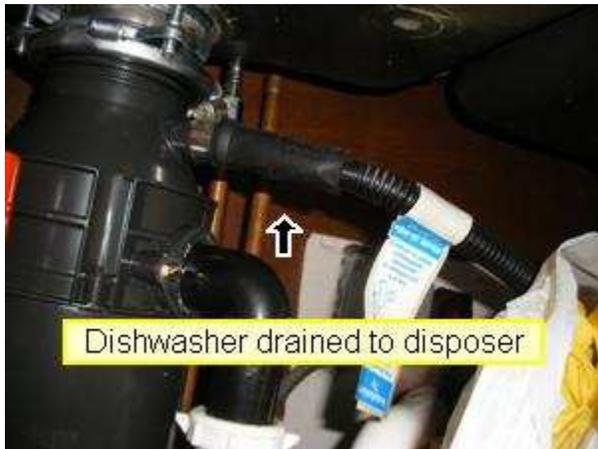
10.0 Picture 1

2) RR - The dishwasher in the kitchen was drained into the disposer (Picture 1) and not the drain pipe, which is not allowed. Recommend that the dishwasher drain hose be connected to the sink drain pipe as required.

1) SD - Recommend that the dishwasher drain be re-installed so as to provide for a high loop, where the dishwasher drain pipe is secured to the underside of the base cabinet countertop and 'looped' so that the loop is at the "flood level" of the sink drain. This will guard against water back flowing from the drain into the dishwasher and guard against contamination of the dishes with drain waste water.
