Inspection Report

Condo Association

**Property Address:
2222 W. Water St.
Swamptown, IL**

Date: 10/10/2008	Time: 1:00 PM	Report ID: Sample 4
Property: 2222 W. Water St. Swamptown, IL	Customer: Condo Association	Real Estate Professional:

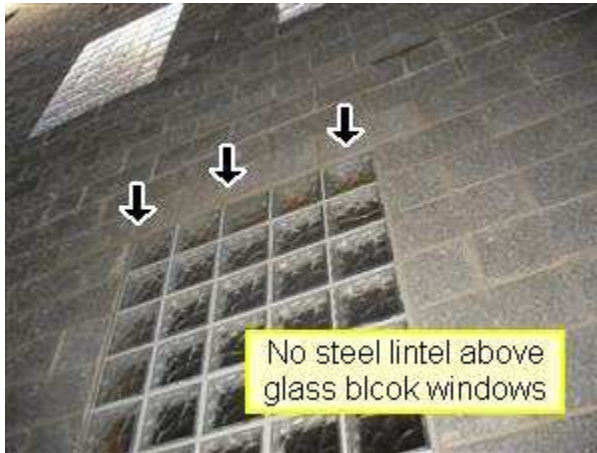
1.2 Picture 1

The building was equipped with multiple glass block windows. The use of such windows and their installation without the upper masonry being supported by steel lintels (Picture 1) is not a recommended construction technique.

1) RR - Recommend that steel lintels be installed above the glass block windows. As an upgrade, it is recommended that the glass block windows be replaced with more energy efficient windows.

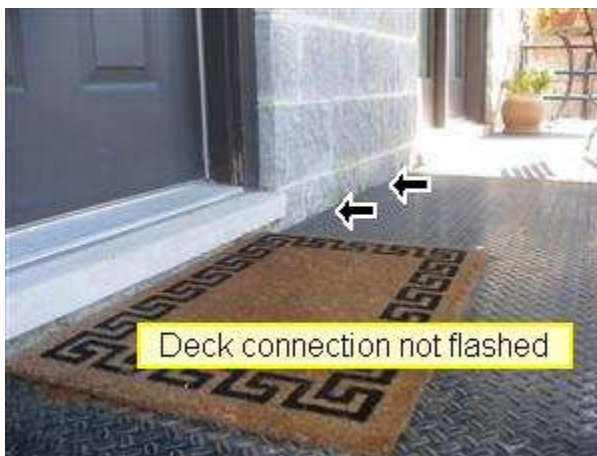
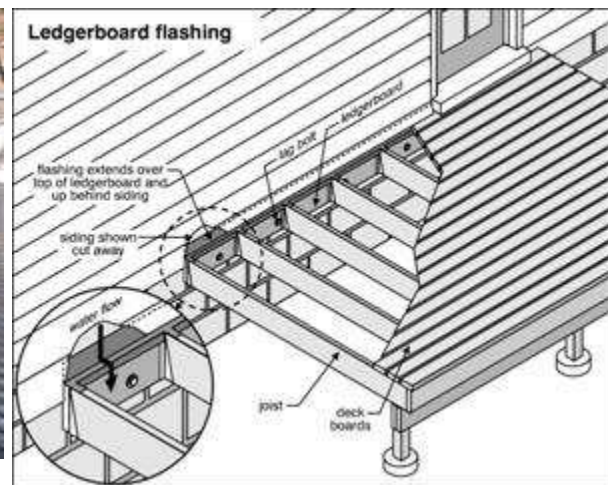
The rear of the building was equipped with metal decks, secured to the building with the required metal rods. Where the deck's ledger boards were attached to the building, there was no flashing (Picture 1). Proper installation of a deck or porch ledger board to a building requires metal flashing above the ledger to divert water running down the exterior wall away from the ledger board and the wall penetrations that holds the ledger board (Picture 2).

- 1) RR - Recommend that the ledger boards for the rear decks / porches be equipped with the required flashing above their ledger boards and that the flashing be counter flashed into the mortar joints and that the work be done by licensed and insured masonry contractors.
- 2) RR - Recommend that the rear metal decks / porches be scraped, primed and painted by a licensed and insured painter who specializes in metal exterior painting.

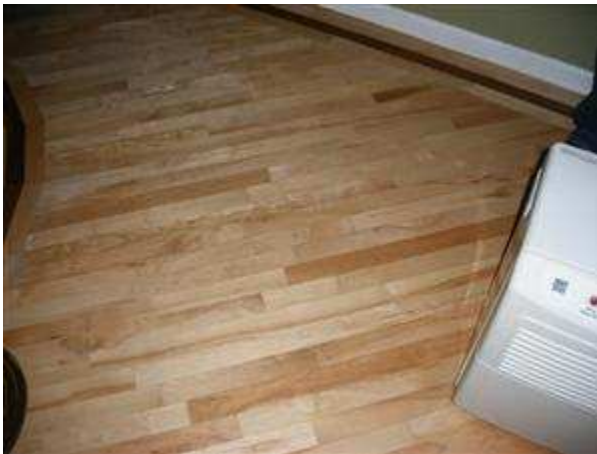
3.4 Picture 1

The lower level floors of the 1st unit were hardwood tongue and groove. They displayed signs of buckling (Picture 1) and water damage, especially along the north wall and in the hallway area. This is caused by a combination of the water intrusion and that the floors were installed directly on the concrete slab floor, which is not an approved installation.

- 1) RR - Recommend that the hardwood floors in the lower level be removed and replaced once the floor level has been raised. The use of a floor raising product, such as Dricore, is highly recommended.
