Inspection Report

**Property Address:
2201 Row Drive # Z
London, IL**

Date: 3/23/2009	Time: 1:30 PM	Report ID: Sample Rowhouse
Property: 2201 Row Drive # Z London, IL	Customer: Charles Rowhouse	Real Estate Professional:

The subject property is a rowhouse unit in a block of rowhouses and was originally built in 1997 (per public records). The unit is in good condition, with some minor wear and tear issues. There was some deflection seen in the garage door lintel and improper porch and deck ledger connections at the front and side of the unit.

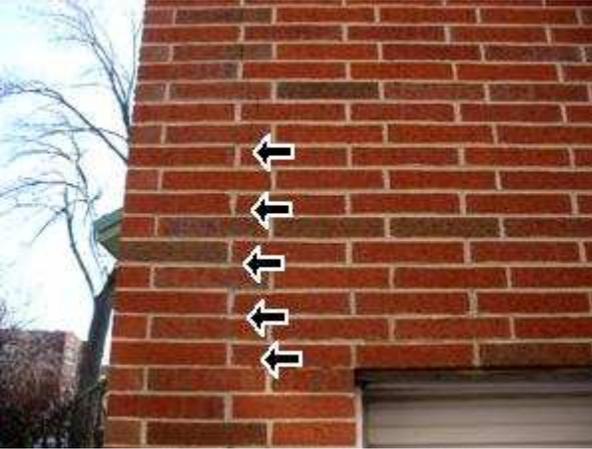
2.0 Picture 1

The brick veneer was, for the most part, unremarkable with the exception of two vertical cracks, one at the east side of the north wall (Picture 1) and one radiating slightly east of center of the garage door beam span (Picture 2). These cracks were not wide, but they radiated through brick and mortar, straight. This may be nothing more that simple deflection of the beam within its normal limits or it may be a more serious condition.

1) RR - Recommend that the brick veneer cracking on the north side of the building be evaluated by a licensed and insured structural engineer.

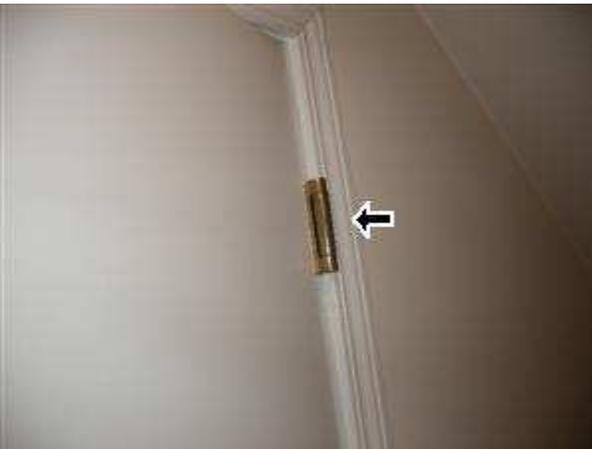
2.2 Picture 1

The door to the attached garage was equipped with spring hinges, but they did not operate properly.

1) SD - Recommend that the door leading from the main house into the garage area be equipped with spring hinges or an automatic door closer in order to ensure fire and carbon monoxide does not migrate into the house from the garage. This is a safety hazard.

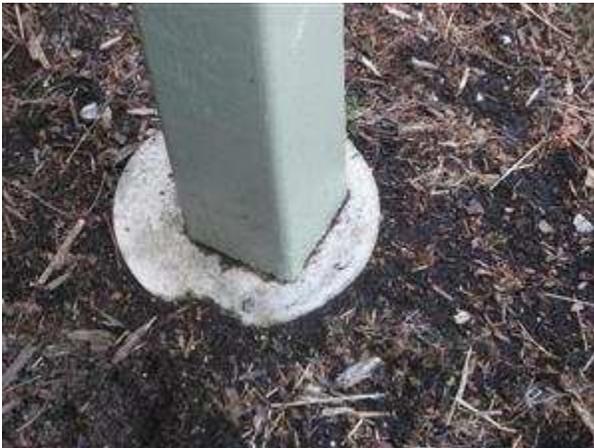
2.7 Picture 1

The front and side of the unit were equipped with wooden deck and porch. The porch posts were properly footed but were not secured by the required metal supports (Picture 1). This will cause the post to rot, over time. The porch and deck were properly installed with metal hangers (Picture 2) but the hardware attaching the ledger boards was undersized and the ledger board was not flashed (Picture 3).

1) RR - Recommend that the installation and construction of the porch and deck be evaluated and repaired by a licensed and insured general contractor.

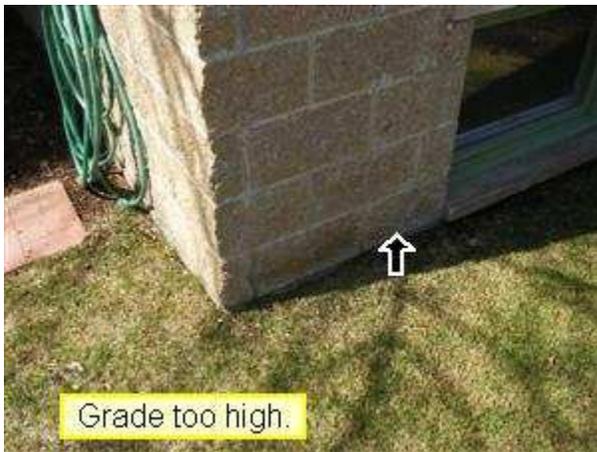
2.10 Picture 1

The grading around the building's perimeter was too high and there were signs of rising damp in the split block (Picture 1).

1) RR - Recommend that the grade around the building be lowered so that, ideally, 6" of foundation wall is exposed above the grade.

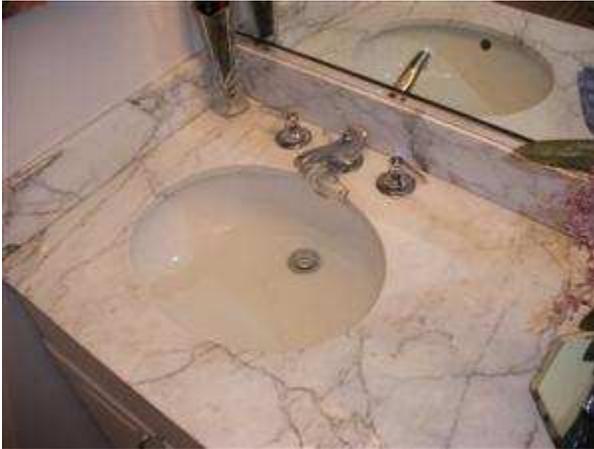
3.3 Picture 1

All interior plumbing fixtures were tested and operated properly. All toilets were properly and securely sealed. All interior faucets were properly equipped with shut-off valves. The drain in the master bath ran slow (Picture 1). The bathtub faucet in the hallway bathroom was not properly sealed to the tile shower enclosure wall (Picture 2).

- 1) WL - Recommend, as a preventative measure, that all basins, sinks and tubs be treated with a gel type drain cleaner every 2 months as a guard against drain blockage.
- 2) RR - Recommend that the bathtub spigot in the hallway bathroom be properly sealed to the tile wall as a guard against water intrusion into the wall.

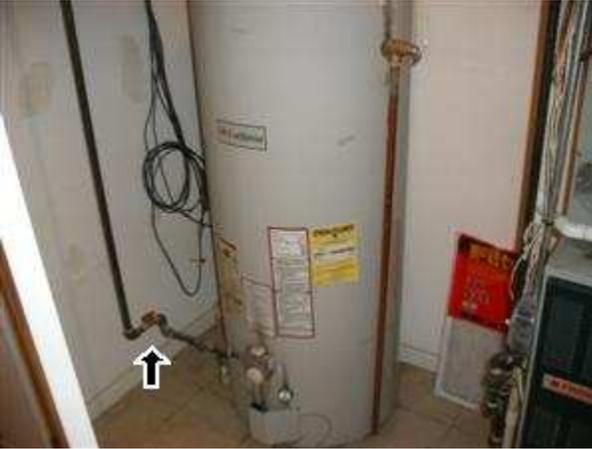
3.5 Picture 1

The water heater was properly installed with di-electric fittings. It was observed through a heating cycle and displayed the proper colored flame. The TPR valve was properly vented to an approved pipe. The water heaters vent flue was properly secured, sloped and secured to the chimney and displayed no signs of backdrafting or carbon monoxide leakage. The water heater's gas shut-off valve is indicated (Picture 1).

2) RR - Recommend that the water heater be equipped with a properly drained drain pan.

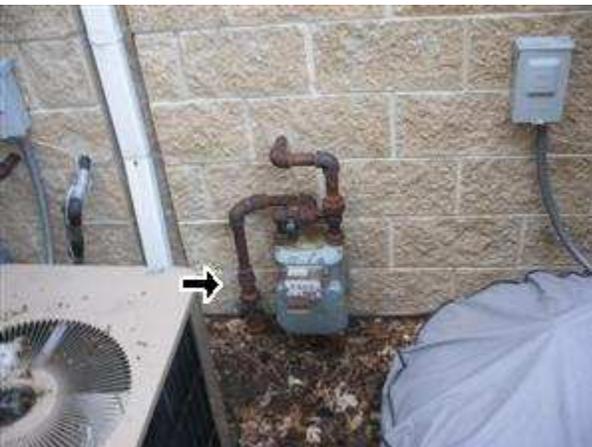
3.7 Picture 1

Main fuel (natural gas) shut-off was located on the utility meter (Picture 1) on the south side of the building.

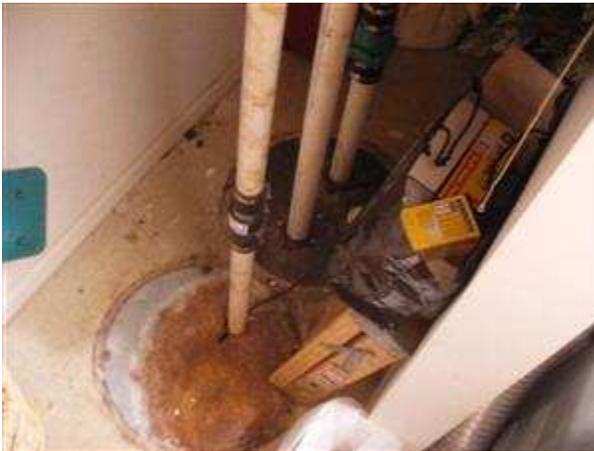
3.9 Picture 1

The house was equipped with a sump pump and an ejector pump (Picture 1). Both were operating properly at the time of the inspection. Neither was equipped with a battery backup.

The sump cover was rusted and should be replaced.

- 1) WL - Also recommend that all sump and ejector pumps be equipped with a 120 volt, UPS battery backup so that their operation is assured during periods of electrical blackout.
- 2) WL - Recommend that the sump and ejector pump check valves be replaced every 5 years.
- 3) RR - Recommend that the sump's cover be replaced.

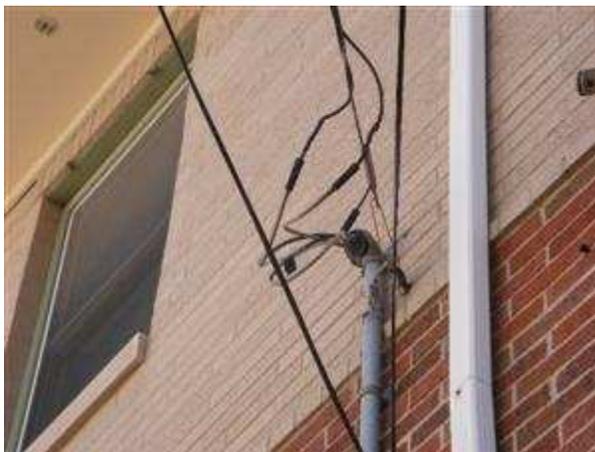
4.0 Picture 1

Main electrical service drop comes from an overhead drop from the utility pole nearby (Picture 1). The drip loop is sufficient and service entrance conductors appear to be proper for the service load. The electrical service meter was located at the north side of the building and was rated for 200 amp service (Picture 2).

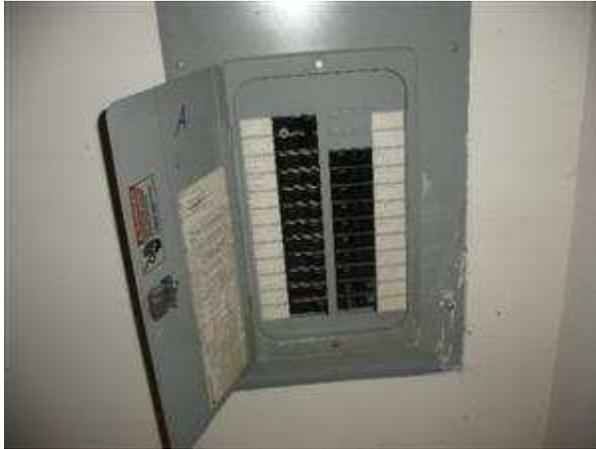
4.1 Picture 1

garage (Picture 1). It was rated for X amps and was without signs of physical damage, rust or pest infiltration. The panel face is properly secured by blunt end screws.

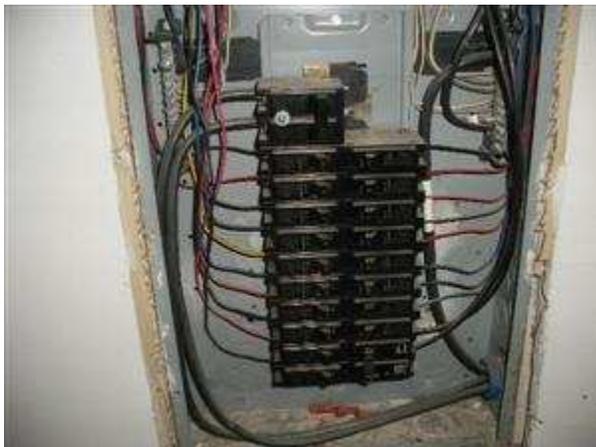
4.2 Picture 1

Wiring technique is neat and orderly (Picture 1). All raceways are properly bonded to the main service panel.

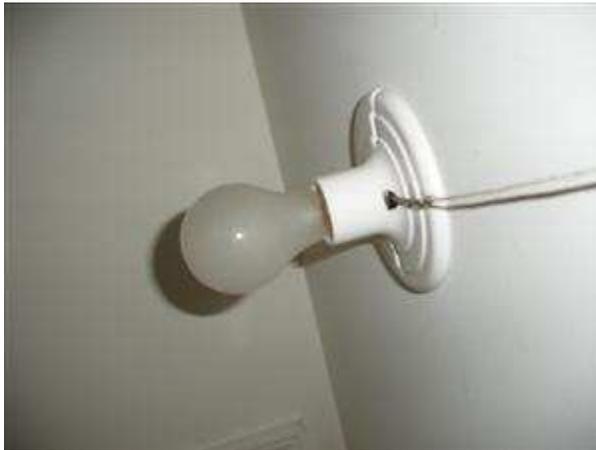
4.3 Picture 1

- Some closet, basement or garage areas were lighted by bare bulb light fixtures (Picture 1). These type of fixtures are no longer approved for use because of the possibility of the bulb breaking and / or the bulb coming in contact with flammable material and starting a fire. These fixtures should be replaced with light fixtures that protect the bulb.
- Some of the electrical receptacles were loose (Picture 2).
- The water and gas piping of the water heater were not bonded, as is now required (Picture 3).

1) SD - Recommend that all bare bulb light fixtures be replaced with light fixtures that protect the bulb from breakage and guard against fires. This is a safety hazard.

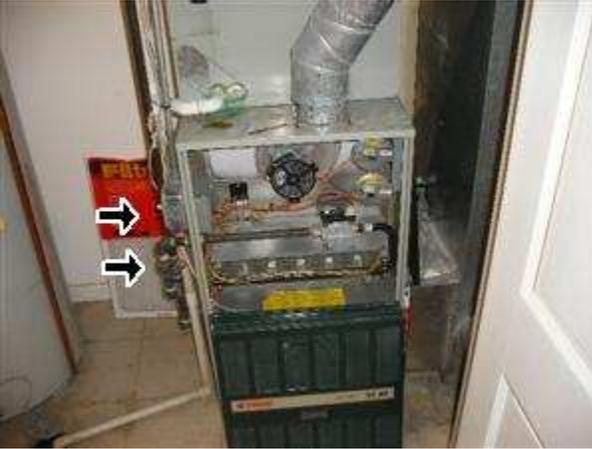
5.0 Picture 1

The subject property was heated by a Trane category 1 mid-efficiency furnace manufactured in 1995 and located in the basement utility closet (Picture 1, gas and electric shut-off indicated). The furnace's serial number was checked against Consumer Products Safety Commission and the manufacturer's web site for defect or recall notices and none were found.

The furnace filter slot was not equipped with a cover and there was considerable leakage into the furnace.

2) RR - Recommend that the furnace filter slot be equipped with a sheet metal cover.

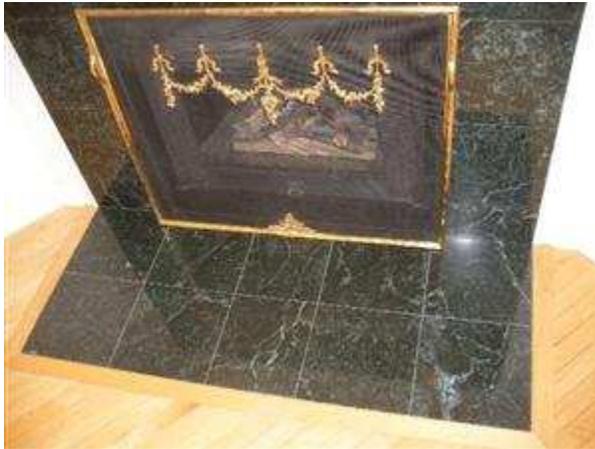
5.6 Picture 1

The unit was equipped with an unvented gas log which operated properly (Picture 1) and had a properly sized hearth. It should be noted that unvented gas log fireplaces do produce a small amount of carbon monoxide and proper operation is essential to safety. Manufacturers require that:

1) WL - The house was equipped with a ventless gas log fireplace. While acceptable and safe, when properly operated, this type of fireplace produces small amounts of carbon monoxide and they must be properly operated. Manufacturer's recommend:

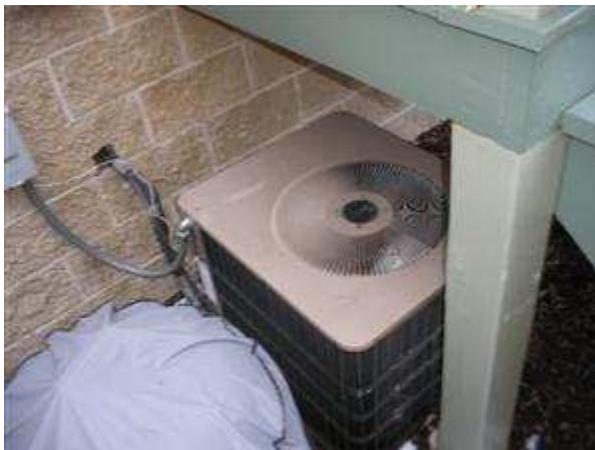
6.0 Picture 1

Air conditioner compressor was a Concept 10 unit, manufactured in 1995 and located on the south side of the building (Picture 1). Its model and serial number were compared to the Consumer Products Safety Commission and manufacturers web site for defect and recall notices and none were found.

1) RR - Recommend that where the A/C lines penetrate the exterior wall be sealed as a guard against water intrusion.

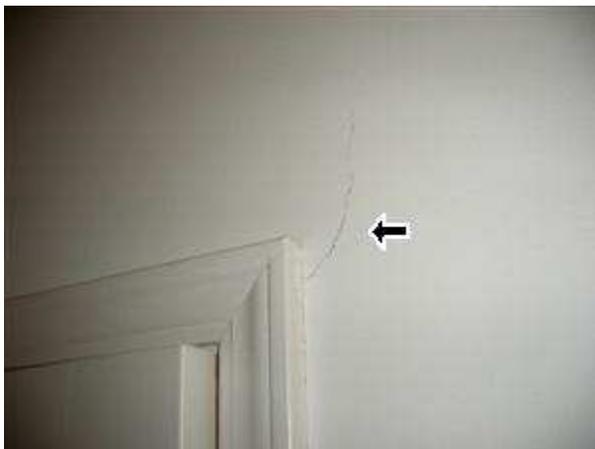
7.1 Picture 1

Walls were finished with drywall and exhibited no signs of sag, warp, loose tape joints or nail pops. There were minor irregularities (Picture 1), normally seen in houses of this age.

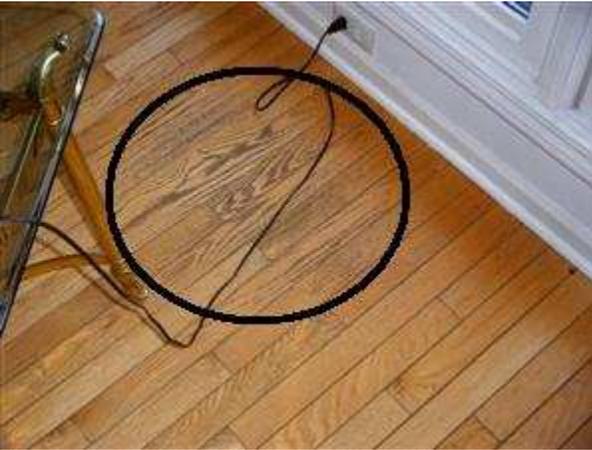
7.3 Picture 1

Floors are hardwood tongue and groove, tile and carpet. The floors displayed no signs of cracking or missing grout. Some of the wooden floor areas displayed wearing of the finish (Picture 1), most probably caused by the use of a water based finish. Floors under carpet could not be observed and were not inspected.

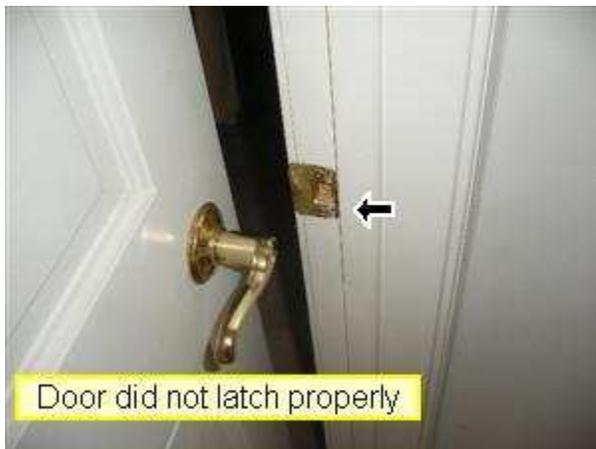
7.8 Picture 1

Interior doors were raised wood and hung straight and plumb with the exception of a couple of 2nd floor doors that were slightly racked. They articulated properly with their latches, again, with the exception of 1 2nd floor door (Picture 1). Some of the bedroom closet doors were racked and did not properly close (Picture 1) and the door knob handle of the closet door in the 2nd bedroom was damaged (Picture 2).

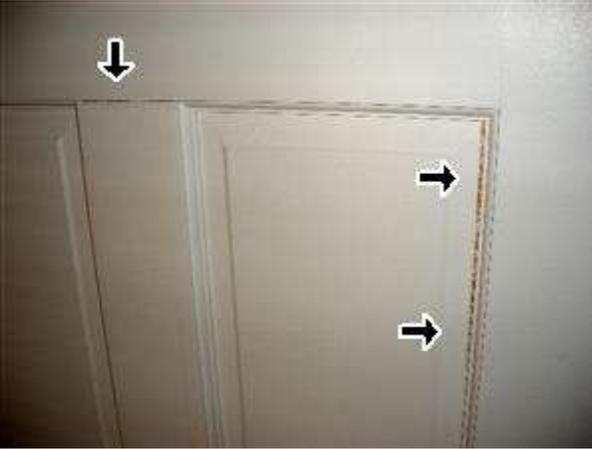
7.8 Picture 3

The doors also displayed signs of movement of their parts (Picture 3) which is caused by humidity changes and excessive humidity in the past.

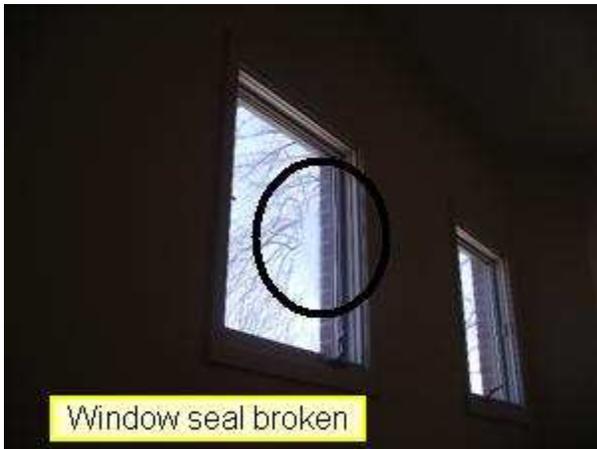
7.10 Picture 1

Interior windows displayed no signs of cracked glass and operated properly when tested. There were no signs of water infiltration or moisture condensation damage on the window trim. The one small fixed window in the east wall of the living room (Picture 1, nearest the front door) displayed fogging which is an indication that its seal was broken.

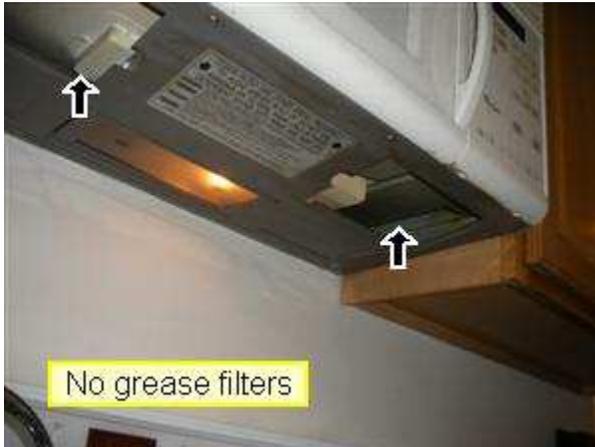
9.2 Picture 1

1) RR - The unit was missing its grease filters (Picture 1) but these can be purchased at most appliance or home improvement stores.
