**WJD Decker**  
**Home Services, LLC**

## Inspection Report

**Property Address:**  
**1234 5th St**  
**Anytown, IL**

<b>Date:</b> 6/10/2008	<b>Time:</b> 10:30 AM	<b>Report ID:</b> Sample Large
<b>Property:</b> 1234 5th St Anytown, IL	<b>Customer:</b> Joe Newhomeowner	<b>Real Estate Professional:</b>

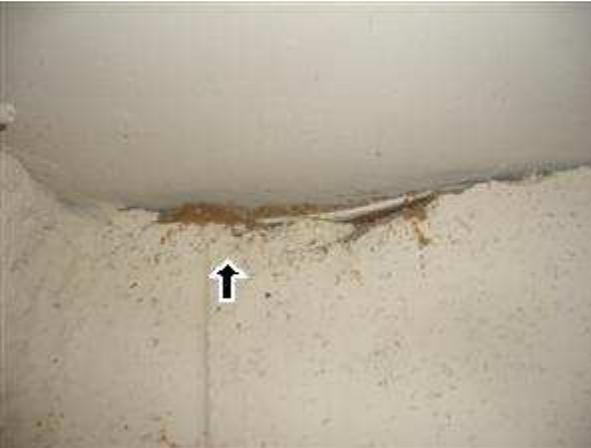
1.0 Picture 3

It should be noted that there was evidence of carpenter ant activity at the garage door lower corner areas ( Picture 2 ) and at the corresponding area in the basement under the garage ( Picture 3 ). Carpenter ants do not "eat" wood, like termites do, but merely burrow into the wood to live there. These insects can be easily dealt with by doing bi-annual perimeter spraying.

2) RR - Recommend evaluation of carpenter ants by a licensed and insured pest contractor.

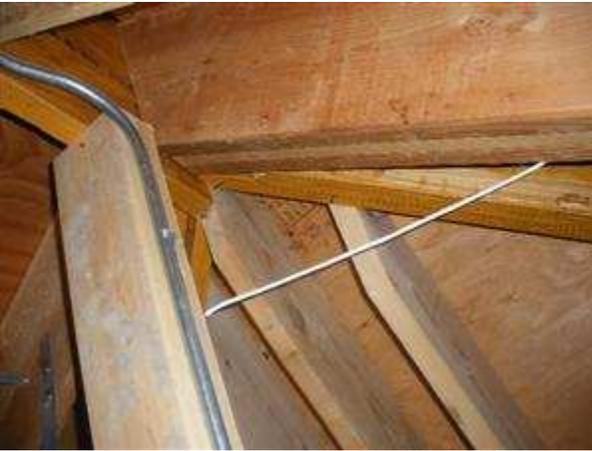
1.6 Picture 1

The roof structure, as observed from the accessible portion of the attic, was stick built with 2 x 12 wooden rafters and large laminated hip rafters ( Picture 1 ) with a large laminated ridgeboard. The roof decking was exterior grade plywood. The roofing members displayed no signs of water staining or displacement. There was some minor evidence of "honeying" which is indicative of elevated temperatures in the attic, but this was minor. Moisture readings of the rafters and roof decking were within normal limits.

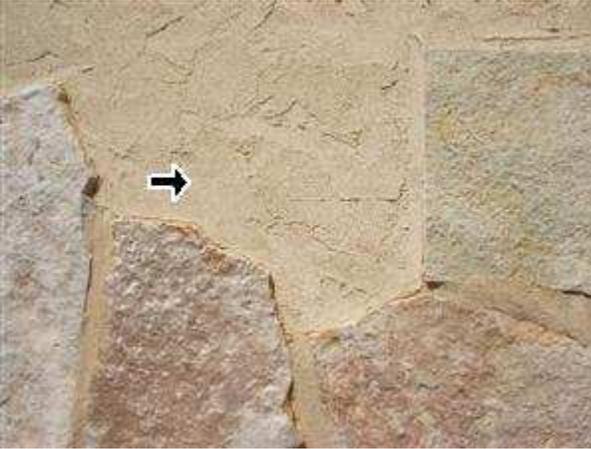
2.0 Picture 1

The exterior walls of the house were covered with a combination of stone veneer and stucco. The stucco displayed no signs of surface cracking but there were a few small areas (located at a few of the stone / stucco interface areas, Picture 1 ) where the stucco was slightly separated from the underlying substrate. There were also some stucco / stone interface areas that displayed minor cracking ( Picture 2 ). Thermal imaging and deep probing moisture meter readings were within normal limits and there were no signs of moisture intrusion behind the stucco.

1) WL - Like any other exterior wall covering, stucco also requires normal maintenance. It is recommended that the stucco be evaluated, every 5 years or so, for signs of cracking or joint leakage and that all mortar cracks between the stucco and the stone be sealed as a guard against water intrusion.

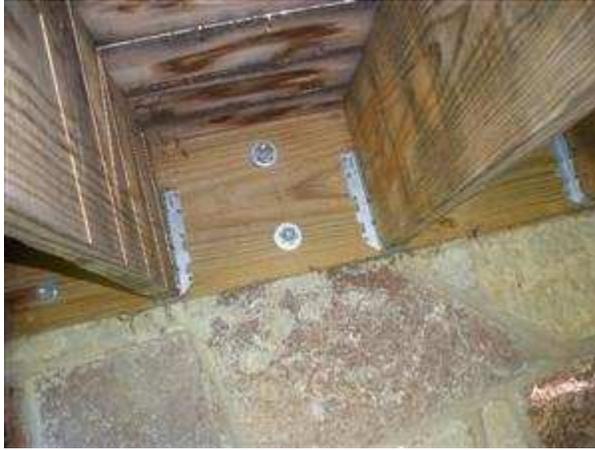
2.7 Picture 1

The rear of the house is equipped with a wooden deck. The deck appeared to be solid, properly secured to the ledger board at the house wall ( Picture 1 ) and displayed no signs of wood rot or structural looseness. The deck support posts were properly footed in concrete ( Picture 2 ).

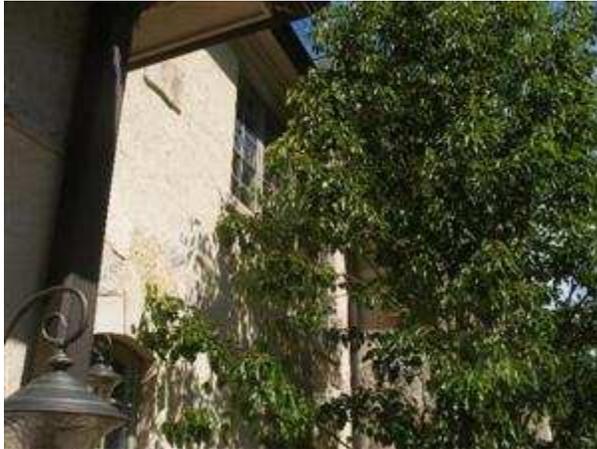
2.10 Picture 1

have its branches trimmed as a guard against damage to the stucco wall. There was also some overgrown plants that were partially blocking the proper ventilation of the A/C compressors ( Picture 2 ).

- 1) RR - Recommend that tree branches brushing the side of the house be trimmed back.
- 2) RR - Recommend that the vegetation growing around the A/C compressors be cut back.
- 3) WL - Recommend that the retaining wall on the east side of the house be monitored for signs of movement. If this wall continues to lean, recommend that it be evaluated and repaired by a licensed and insured masonry contractor.

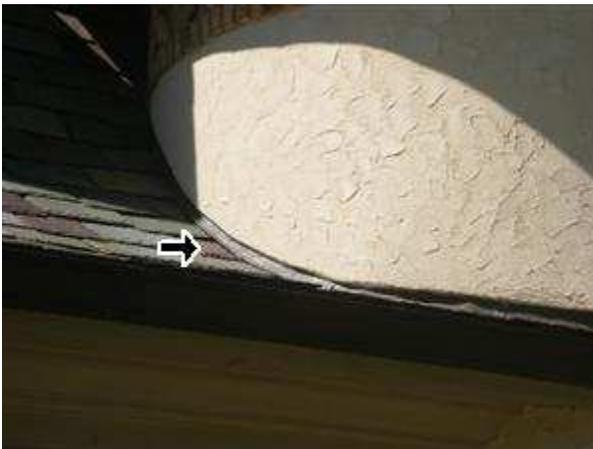
3.1 Picture 1

All roof penetrations were inspected and displayed proper flashing. The chimney was equipped with step and counter flashing which was intact. The flashing of the roof to the stucco sidewalls ( Picture 1 ) was metal and the stucco was properly installed so as not to contact the roof.

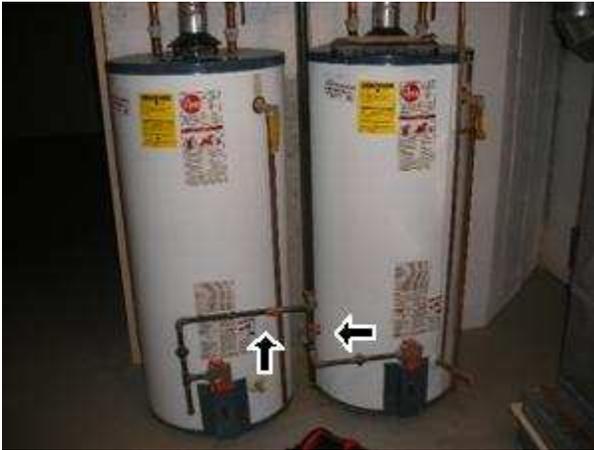
4.5 Picture 1

valve is indicated ( Picture 1 ).

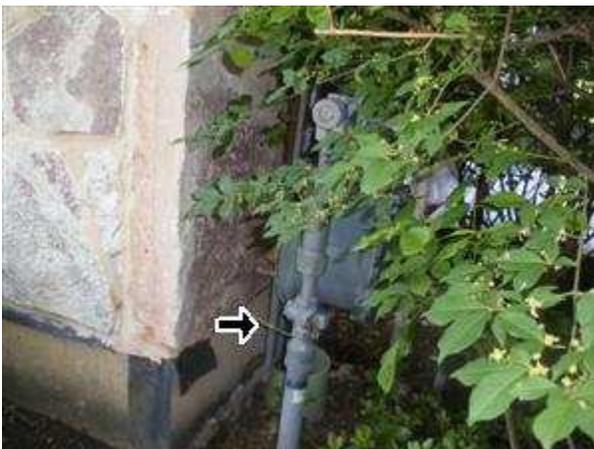
4.7 Picture 1

Main fuel (natural gas) shut-off was located on the utility meter ( Picture 1 ) at the northwest corner of the house.

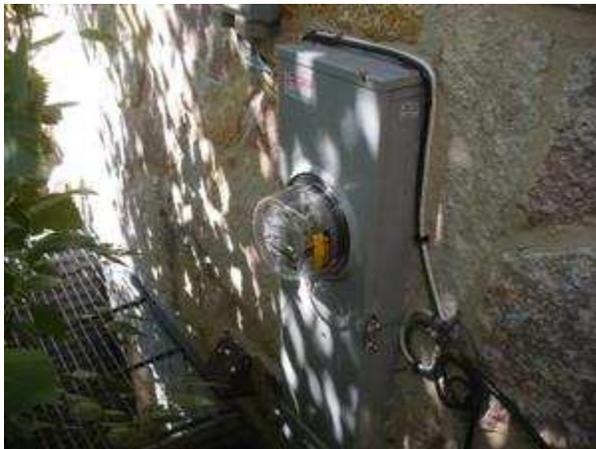
5.0 Picture 1

Electrical service is supplied by means of an underground (lateral) service drop from the utility pole to the meter box located on the east side of the house (Picture 1). The meter was rated for 200 amp service.

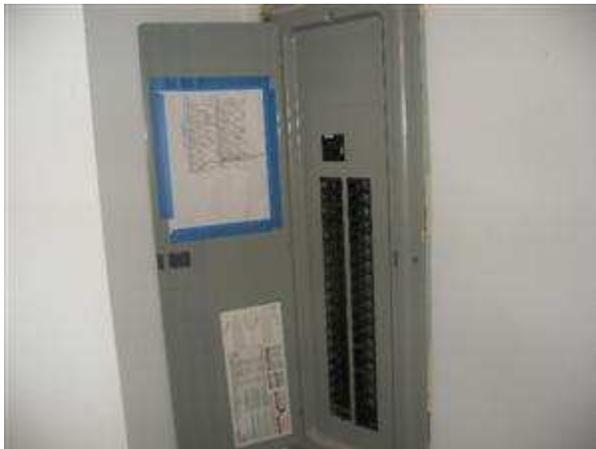
5.1 Picture 1

All raceways are metal conduit and are properly secured and bonded. The grounding conductor and the neutral conductor are properly floated and the ground conductor was properly bonded to the panel.

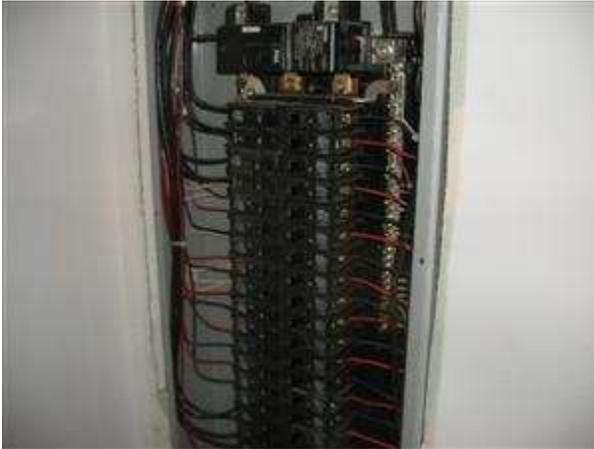
5.2 Picture 1

Wiring technique is neat and orderly ( Picture 1 ). All raceways are properly bonded to the main service panel.

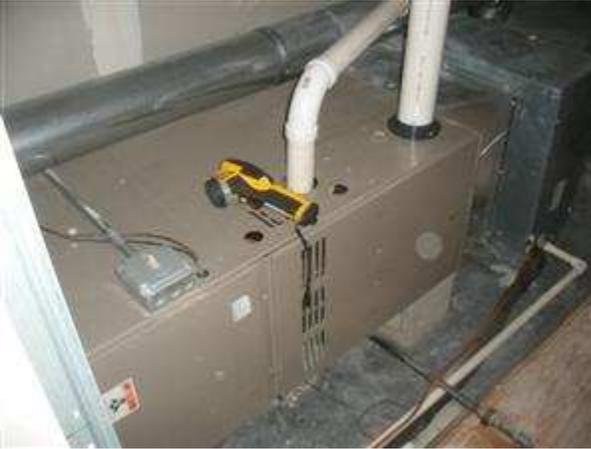
6.0 Picture 1

Heating was provided by means to two furnaces, one located in the basement and one located in the attic area. Both furnaces were Goodman high-efficiency units manufactured in 2002. The attic furnace ( Picture 1 ) was properly installed so as to draw their combustion air from the exterior of the house while the basement furnace ( Picture 2 ) was installed without a combustion air vent. The lack of a combustion air vent on the basement furnace is allowed, but lowers this furnace's efficiency by about 10%. Both furnaces were operated. They both exhibited the proper color flame and their temperature limit switches and blower times operated properly. Their measured temperature differential exceeded the recommended 15 degrees.

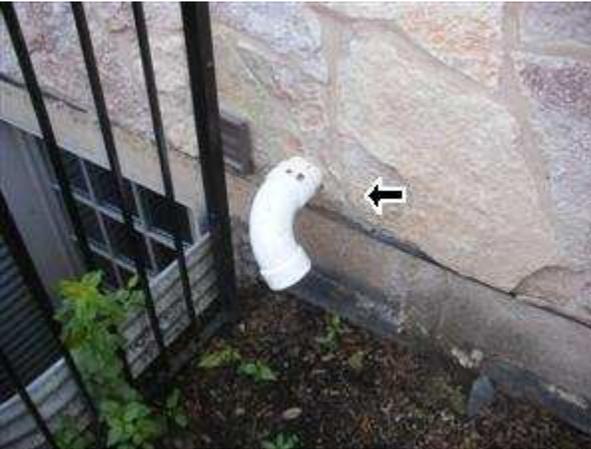
6.2 Picture 1

The furnaces was properly vented by means of PVC piping. The required combustion air intake vent was properly installed for the attic furnace. The basement furnace was vented out the west side of the house ( Picture 1 ).

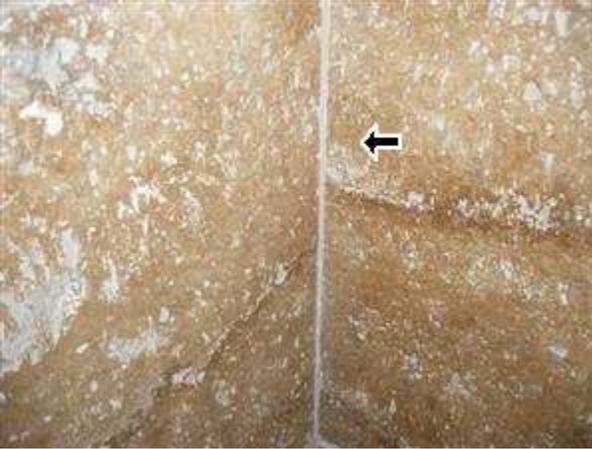
8.2 Picture 1

Bathroom walls were covered with stone and marble tile in the shower and bathtub enclosures. The tile displayed no signs of displacement or looseness. RF deep probing moisture meter readings displayed no areas of increased moisture behind the tiles. There were some minor settling cracks seen at the interior wall corners of the large shower in the master bathroom and in the smaller bathroom in the basement.

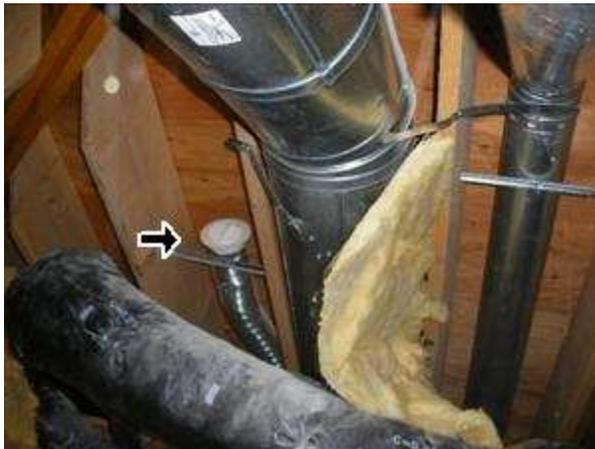
9.1 Picture 1

Bathrooms were equipped with ceiling exhaust fans which were, mostly, properly vented to the exterior. There was one bathroom (the master bathroom) where the exhaust fan appeared to be vented to the attic area ( Picture 1 ) but given the condition and ventilation of the attic area, this did not appear to be a problem.

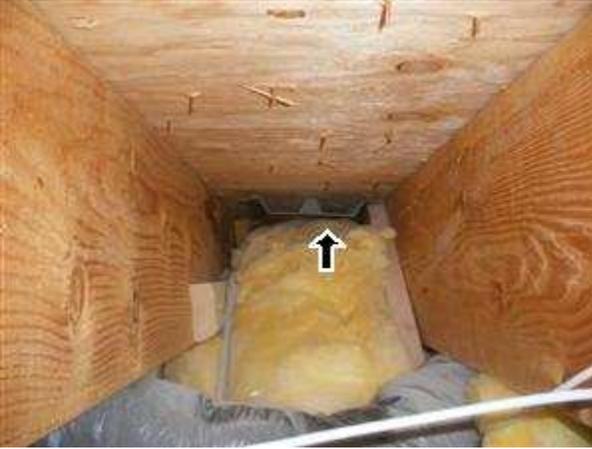
9.2 Picture 1

The attic is ventilated by a combination of soffit vents and ridge vents. The recommended baffles were in place over the soffit vents ( Picture 1 ) to guard against insulation blocking the vents. Given the humid conditions present for several days prior to the inspection and the low moisture levels in the attic, the ventilation of the attic area appeared to be sufficient.
