WJD Decker
Home Services, LLC

Inspection Report

**Property Address:
1121 Small Street
Smallville, IL 60000**

Date: 10/2/2008	Time: 9:30 AM	Report ID: Sample Small
Property: 1121 Small Street Smallville, IL 60000	Customer: George Small	Real Estate Professional:

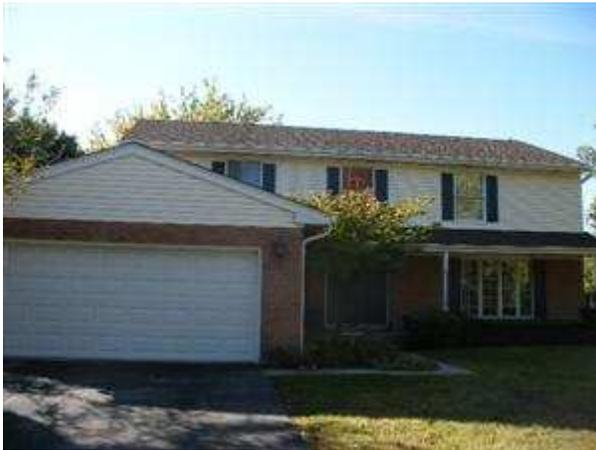
Front View

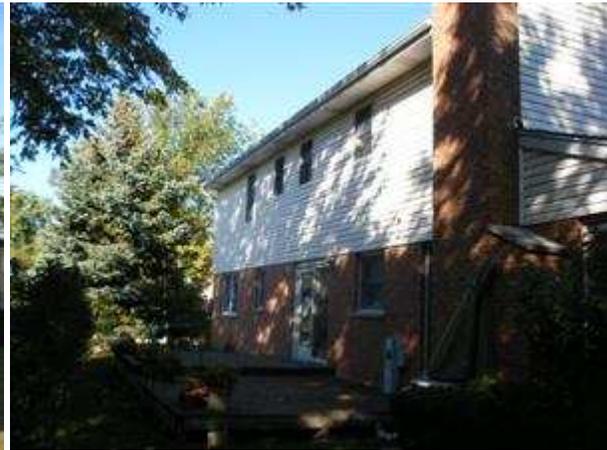
Rear View

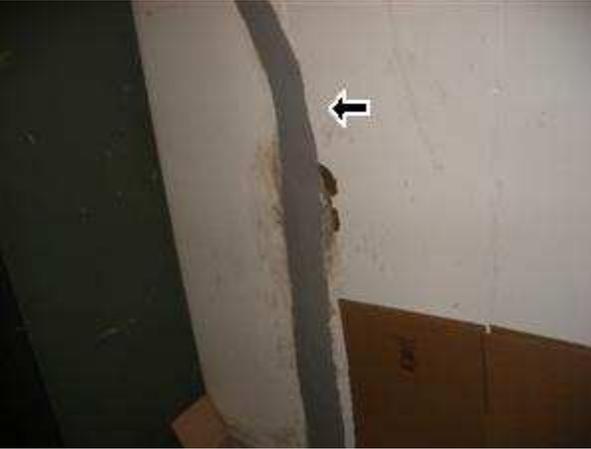
1.0 Picture 1

Foundation was poured concrete without exterior signs of cracking, efflorescence or water intrusion where observed. Interior inspection showed no signs of staining, water intrusion or efflorescence. There were a few minor cracks seen, radiating downward from the steel window pockets on the foundation wall, but these are not considered significant. There was one crack that was sealed with epoxy (Picture 1). The concrete slab displayed some minor cracking and signs of past water (efflorescence, Picture 2) but this was minor. The wall penetration for the main sewer pipe displayed some efflorescence (Picture 3) and should be sealed with epoxy.

2) RR - Recommend that the slab cracks be sealed with self-leveling polyurethane caulk.

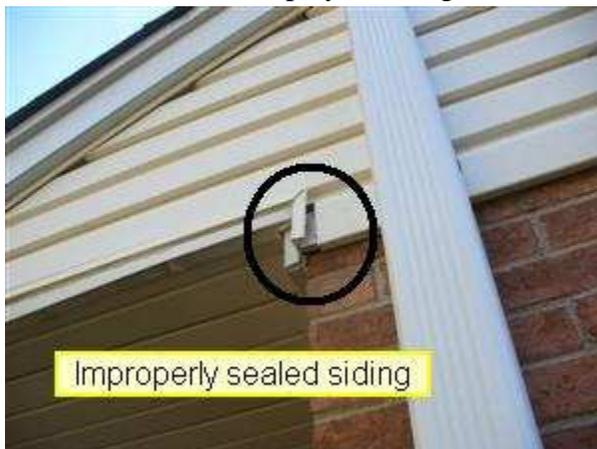
2.0 Picture 1

The exterior walls of the house were covered with vinyl siding, with the lower level covered with brick veneer with stone trim. The vinyl siding displayed no signs of physical damage and was properly secured to the house. The siding ends were properly equipped with J bar terminations. There was some small areas that displayed openings where the siding was not properly sealed (Picture 1). The brick veneer displayed some minor signs of cracking at the garage lintel (Picture 2) and was properly equipped with weep holes where it met the foundation wall (Picture 3). The limestone trim displayed no signs of cracking.

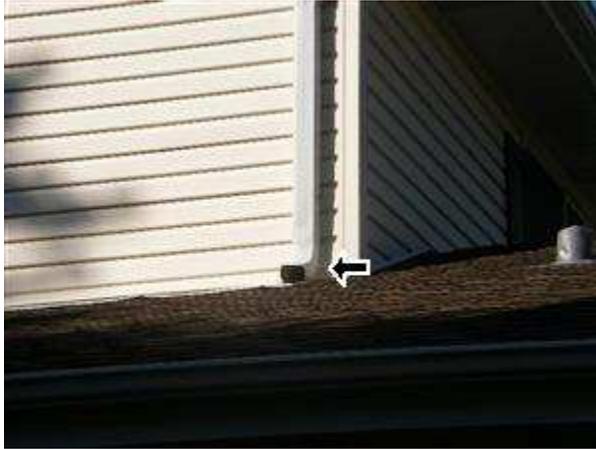
3.2 Picture 1

The roof is drained by means of metal gutters that are secured to the fascia boards by means of metal hangers. The spacing of the gutter supports meets the modern standard of a maximum of 18" spacing between supports. The gutters displayed no signs of rust or physical damage and appear to be properly sloped. There are areas where the upper sections of the gutter system drain directly onto lower roof surfaces (Picture 1). This will cause accelerated deterioration of the roof surface under these areas and greatly decrease the life of the roof. This condition will also violate the warranty conditions of most roofing material manufacturers.

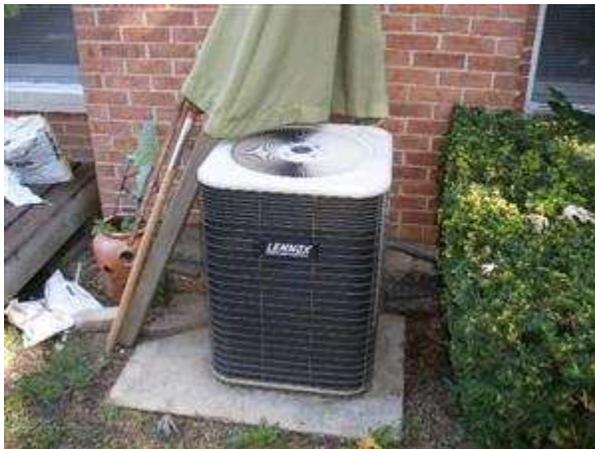
7.0 Picture 1

It is equipped with a disconnect in clear sight and not obstructed. Its gas a liquid lines were unknicked and properly insulated. The air conditioner was operated and is serviceable, delivering a differential between supply and return ducts of greater than 15 degrees.
